PROJECT FIGARO PART 2

Last issue we explained how and why we have bought a Nissan Figaro as a project car. This issue we make a start on getting it ready for the road. REPORT: SIMON GOLDSWORTHY

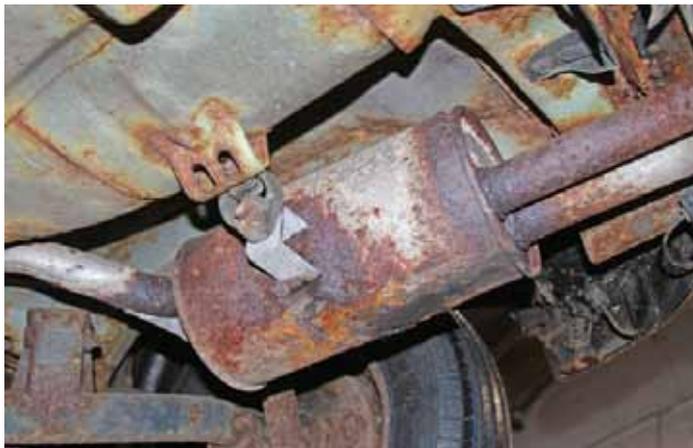
1 You could hear that the exhaust was blowing, and one glance under the back of the car showed that the silencer was in poor shape, with the securing brackets pulling away from its body.

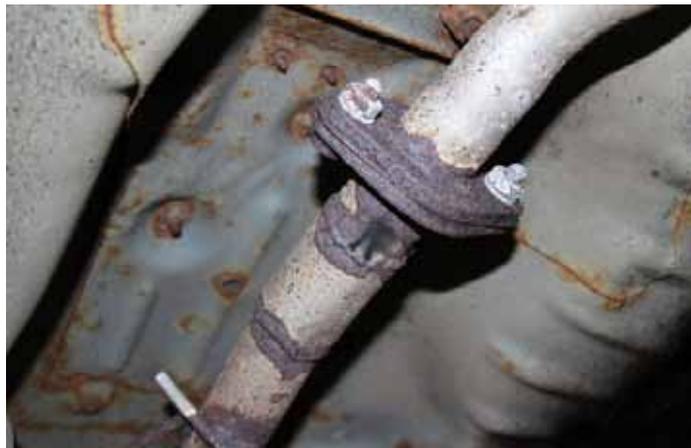
2 The exhaust is in two pieces after the manifold and cat, with an intermediate pipe joining the rear section here. This looks to have been welded in the past with a sleeve section.

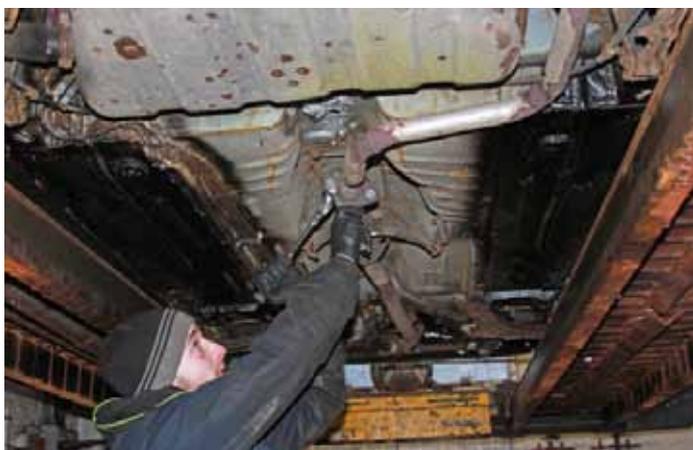
3 Just ahead of this join, the exhaust is secured to rubber spring hangers bolted to each side of the transmission tunnel. Clearly these securing hangers were far from standard, which didn't bode well.

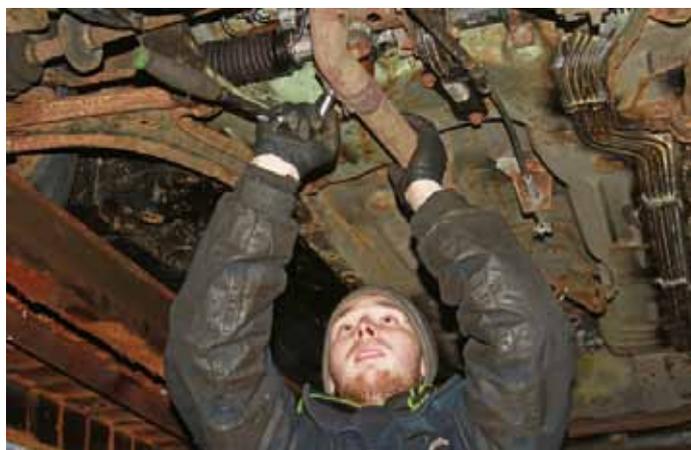
4 There was one further support just before the pipe curved up to meet the manifold. This was made up of a sheet steel clamp around the pipe that was secured to a single rubber bobbin.

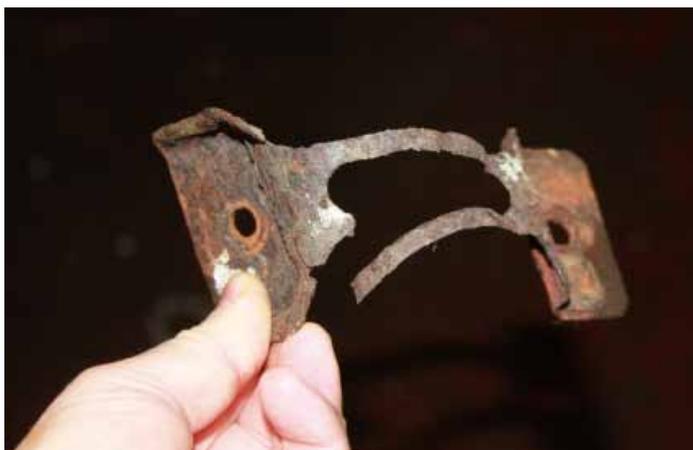
5 Unfortunately, that steel clamp was well rotten, and would not have offered much in the way of support. A replacement for this was not in the fitting kit that came with our new exhaust.

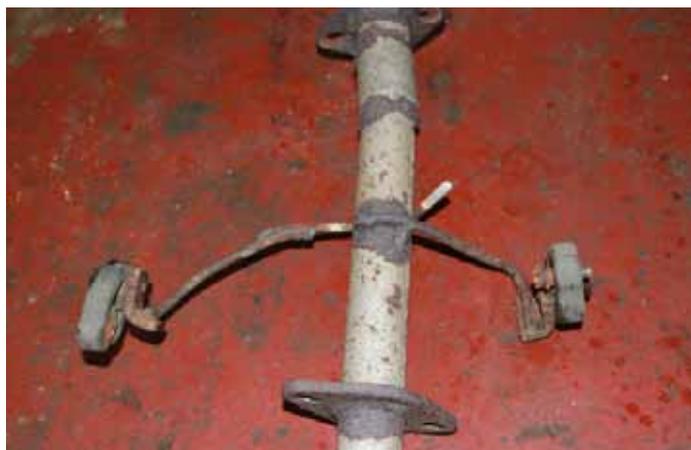
6 And this was the full extent of the home-brew centre fixing bracket. Notice how the welds have produced rust-prone and potentially weakened points in an otherwise sound pipe.

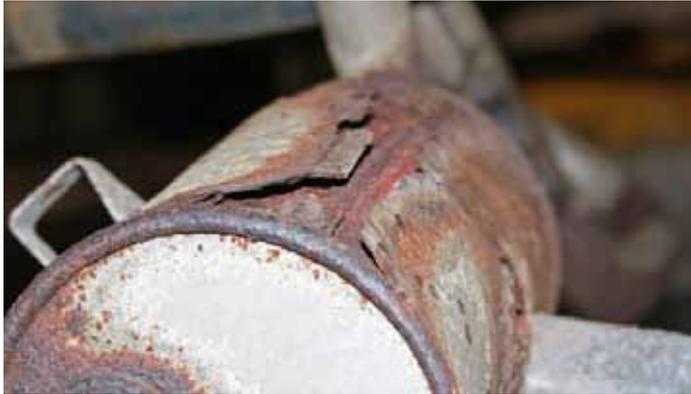
7 Talking of rust-prone, this was the top surface of the silencer. It had not been immediately obvious from underneath just how seriously corroded the silencer was. No wonder it was blowing.

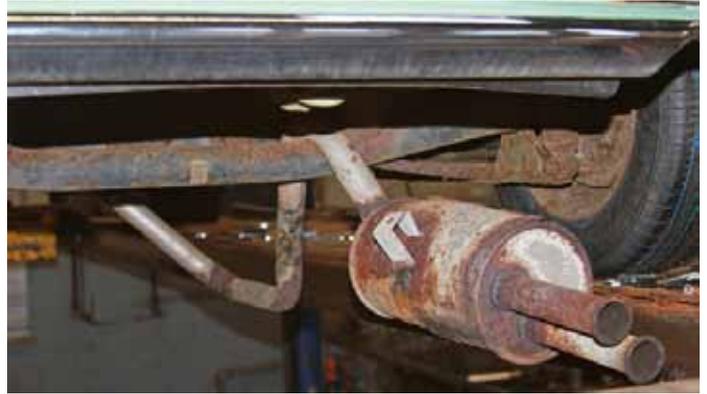
8 Since we had the car up on a four-post ramp and so sitting on its wheels, we couldn't initially figure out how to get the old rear pipe out and the new one in as there was not enough room.

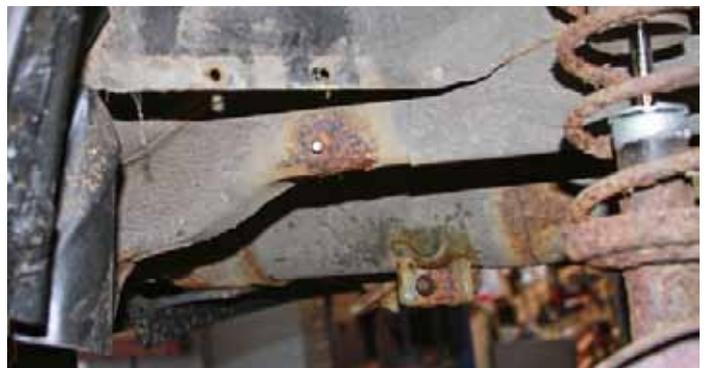
10 Thanks to careful use by Danny of penetrating spray, only one of the securing bolts snapped off rather than came undone, the outer one by the silencer.

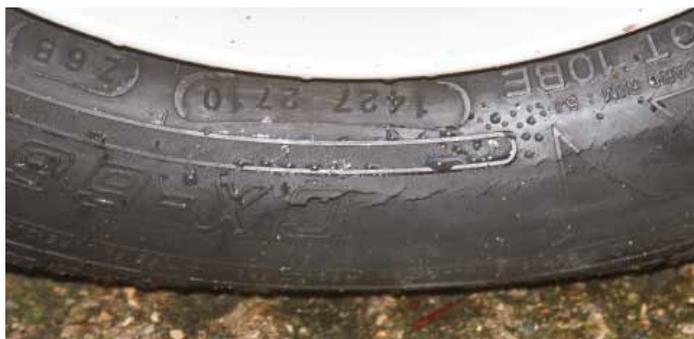
15 The next job to get the Figaro safely mobile was to change the tyres. The ones on it were from 2006, 2007, 2010 and 2019, and all but the newest one had serious cracks in their sidewalls.

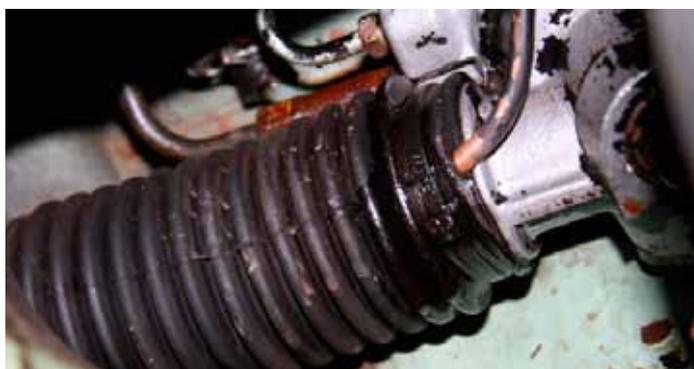
19 The power steering reservoir was just below its dipstick, though. Topping it up was simple, but where has the fluid been going? The rack gaiters looked suspiciously wet – we shall have to monitor that and see if the level drops again.

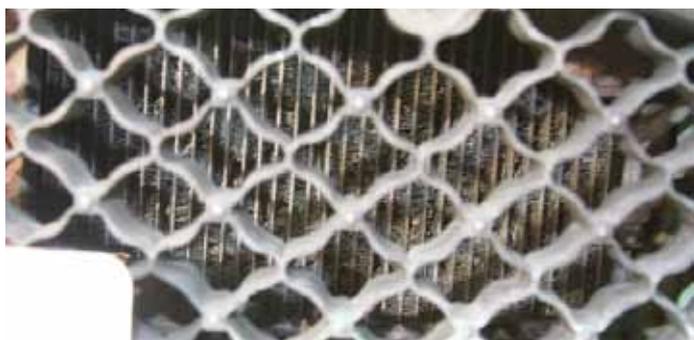
21 Unfortunately, the radiator itself is not in such great shape, with most of the cooling fins on its forward face having disintegrated. Some of the hose clamps were rusty and cutting into the hoses too, so they will be replaced.

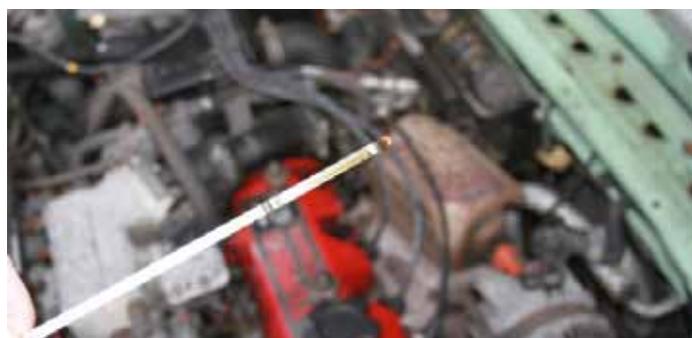
18 As well as getting the tyres and exhaust sorted, we checked out some of the other pre-driving essentials. The engine oil was up to level, and had clearly been changed very recently.

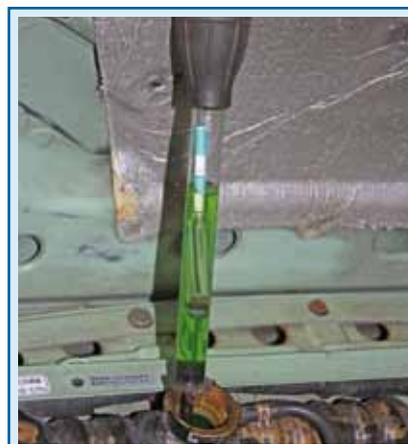
20 The coolant was also very clean and up to the correct level. The coolant tester showed that its antifreeze protection was up to strength too, though we cannot be sure what type of fluid it is. This will be a problem when we next need to top it up.

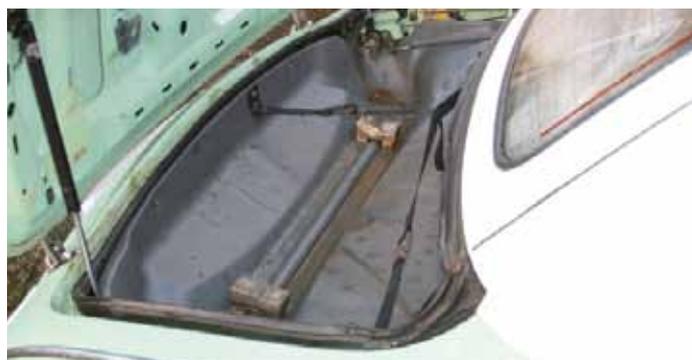
22 Not something that would stop the Figaro being mobile, but the stowage compartment for the folding roof was wet (it should be no more than damp) and mouldy, needing a good scrub. »

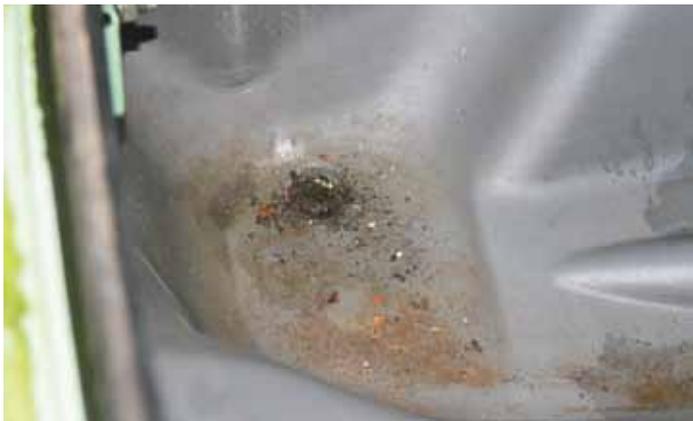
23 It was like this because the drain holes had become blocked. Cleaning them out with a round brush and then an airline should stop the stowage compartment from holding water.

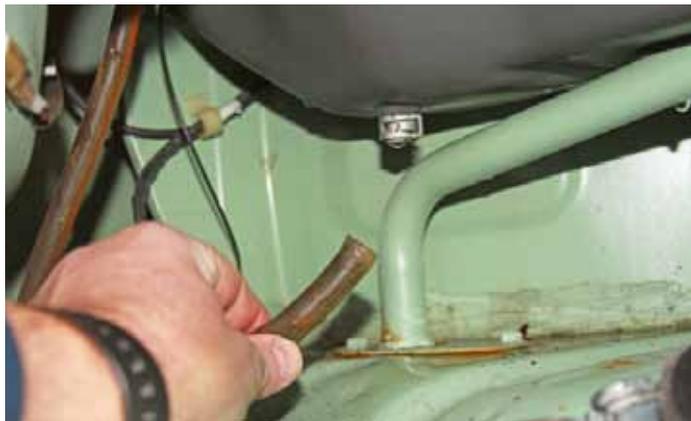
24 However, the drain holes feed into pipes that go through the boot proper, and which take the water out to exit under the car. Both of ours had become detached – perhaps knocked by unsecured luggage, or when we cleaned out the holes?

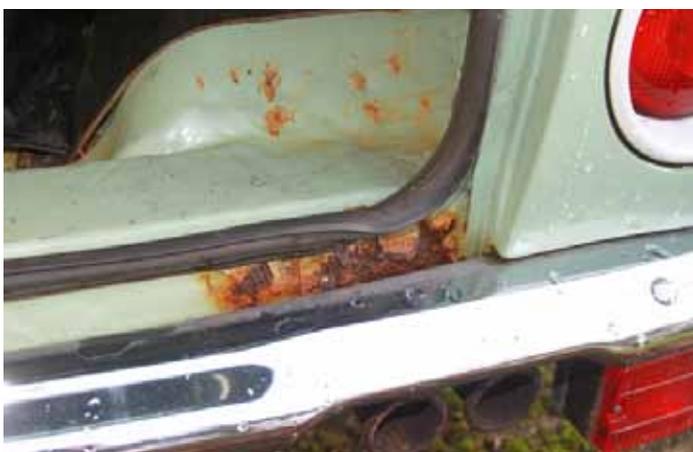
25 The pipes were easy enough to reattach, but this area of rust below the bootlid may be connected to the damp. It is the worst bit of rust on the car and the area will need tidying up.

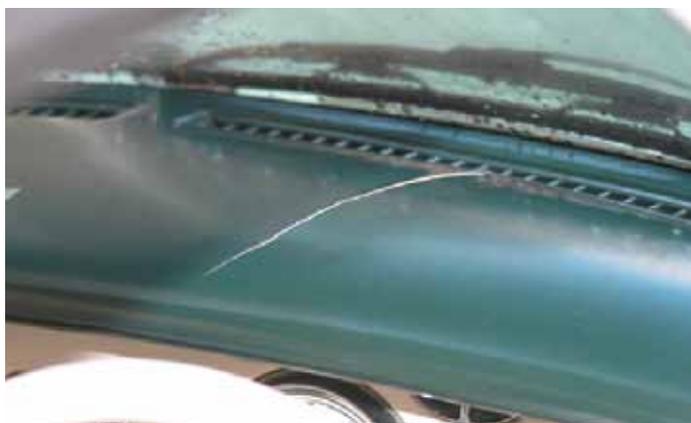
26 Talking of tidying, not mechanically crucial but something we would like to sort out is this unsightly crack in the top of the dash, a big job we hope the Figaro Shop will help us fix.
