FIGARO PROJECT PART 8 UNEXPECTED RUST REPAIRS

Investigating an odd-looking previous repair under the nearside sill reveals fibreglass matting. There is no other option but to peel it off and discover what horrors lurk beneath. REPORT: SIMON GOLDSWORTHY

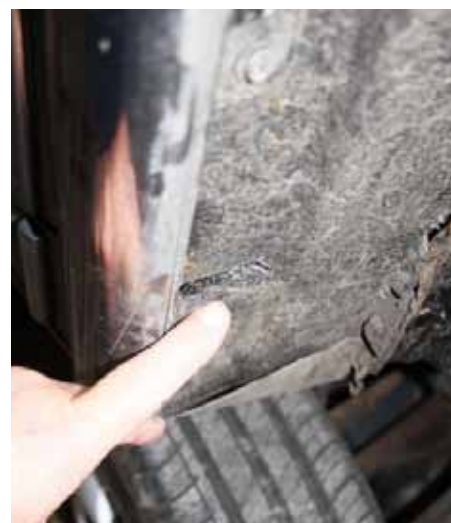
1 This was the curious gap under the sill just behind the nearside front wheel which was spotted by the guys at Rustbuster and aroused our curiosity when we visited them. The rest of both sills were clearly solid metal, but this area somehow just seemed wrong.

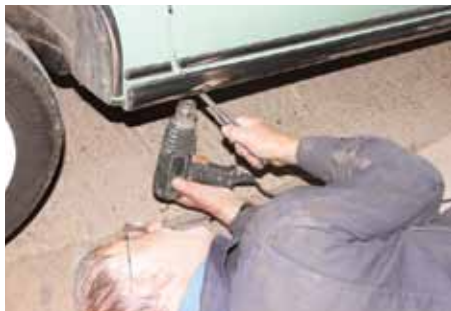
2 The first job was to clean off the underseal that had been applied to disguise the 'repair.' We would later have to remove the stainless trim along the side of the sill too, but we didn't know that yet. Fortunately it popped off the plastic retaining lugs without issue.

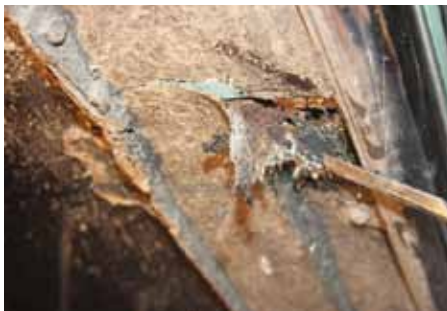
3 It didn't take long for us to get that sinking feeling as the first strands of fibreglass matting were revealed. We can only hope that a previous owner did not pay a professional for this work and get ripped off. On the other hand, that means they must have bodged it themselves...

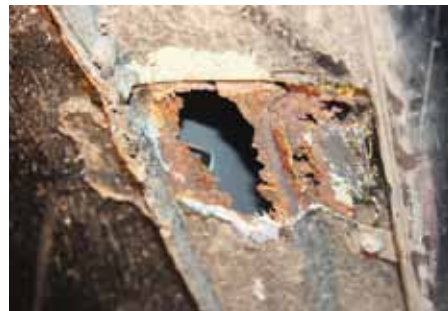
4 Pulling off the fibreglass revealed this hole in the metal. The sill structure was described in the introduction – that large hole is in the horizontal section of the central panel where it leads inwards to the inner sill/floorpan before folding down to a flange and being spot welded to them.

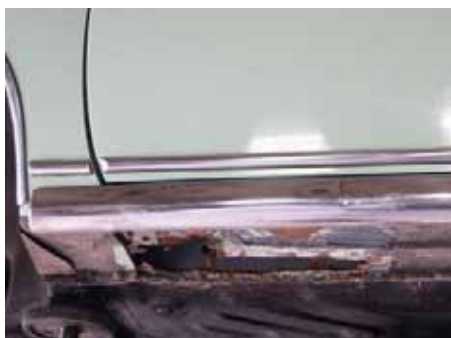
5 And this was the full extent of the missing metal after Alan had cut ruthlessly back to sound metal – this saw a large chunk of the outer sill cut away too.

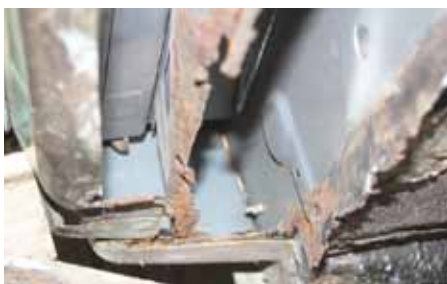
6 Fortunately, the corrosion was all at the bottom of the panels, and the rest of the structure was in perfect condition, giving Alan something to weld to. Here you can see the inner sill on the right and the outer sill curving under on the left.

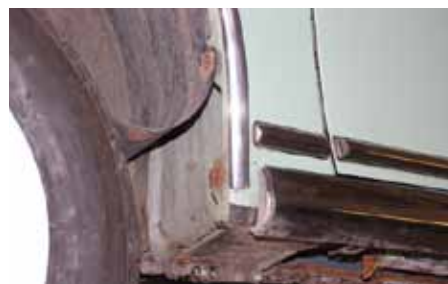
7 Further forward, the bottom of the inner wheelarch was unaffected. Here the wheelarch liner is folded out of the way to allow inspection. The front wings are plastic, so the bottom of that could also be eased out of the way.
