# PROJECT FIGARO PART 3 BUILDING IN RELIABILITY

Two main tasks are completed on the Figaro this issue, one a precautionary measure and the other an essential repair. REPORT: SIMON GOLDSWORTHY

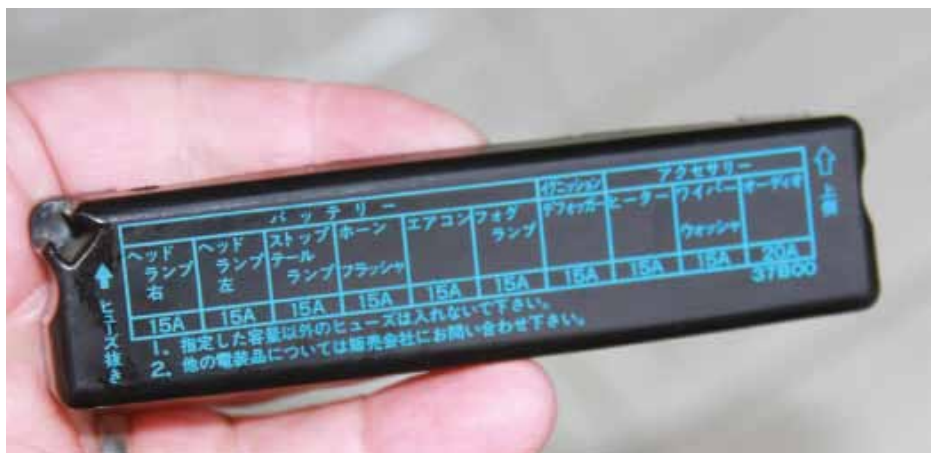
**1** The descriptions on the fusebox cover are written in Japanese. Fortunately the Figaro Owners Club has translated them into English; unfortunately our indicator problem had not been caused by anything as simple as a blown fuse.

So, for example, the club website had a very helpful translation of the Japanese writing on the fusebox cover. That enabled me to ascertain that a blown fuse was not the cause of my failed indicators. The club's technical forum also explained where the indicator relay was located, and how to get to it. Access was not totally straightforward, but as the pictures show, I got there in the end.

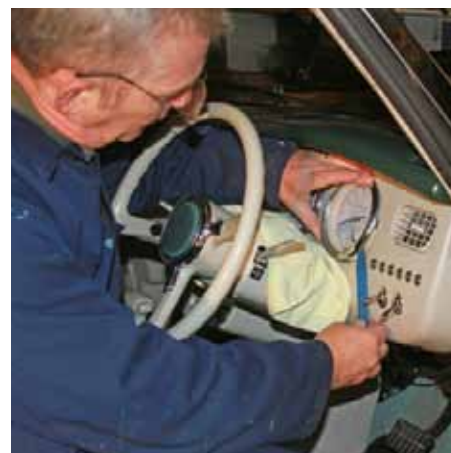
**2** The finger of suspicion was then pointed firmly at the indicator relay. Again the FOC came to the rescue with a video showing where it was, and how to access it. That started by removing the trim ring around the rev counter...

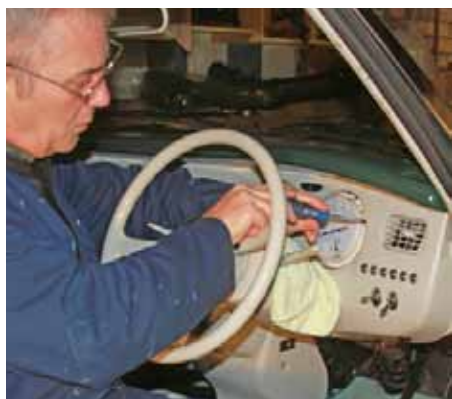
**3** ...followed by the rev counter itself, which is held in by three screws. (Note the warning lights and switches on the dash – The Figaro Shop have produced a helpful online video showing what the lights mean and what the switches do.)

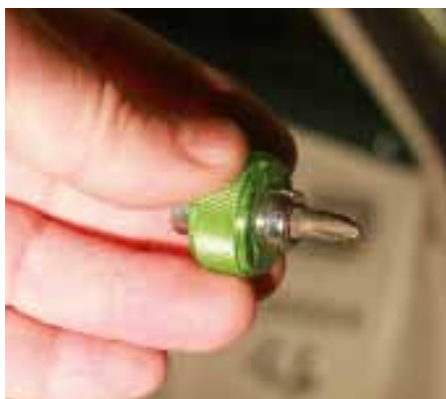
**4** Some of the screws turned out to have very limited access room in front of them for a screwdriver. This handy little ratchet with a Philips bit inserted proved smaller than a stubby screwdriver and was helpful in some cases.

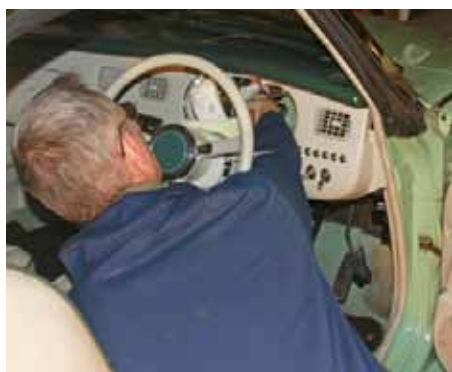
**5** Although the relay itself is located behind the speedometer, the rev counter has to come out first to provide easier access for disconnecting the speedo cable. The speedo itself then comes out the same way as the rev counter.

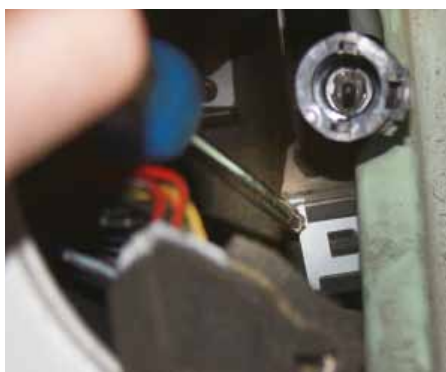
**6** The screwdriver is pointing to the indicator relay, which is held by a screw into the column support. There was very little room to get even a tiny screwdriver onto the head, and it was a major pain in the proverbial to remove.

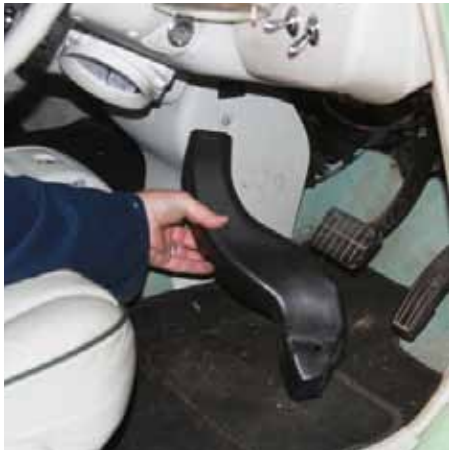
**7** In the end, Simon had to remove some of the plastic air trunking to add a little extra wiggle room behind the dash. He couldn't help wondering though why Nissan hadn't simply fitted the relay alongside the fuse box.

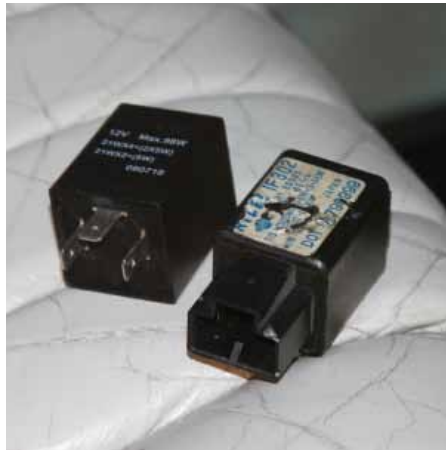
**8** The new relay (on the left) was not an original part; it cost £10.20, but lacked the fixing bracket. That was not a concern, as Simon cable-tied it in a more accessible position anyway and with that, the indicators were functioning again.

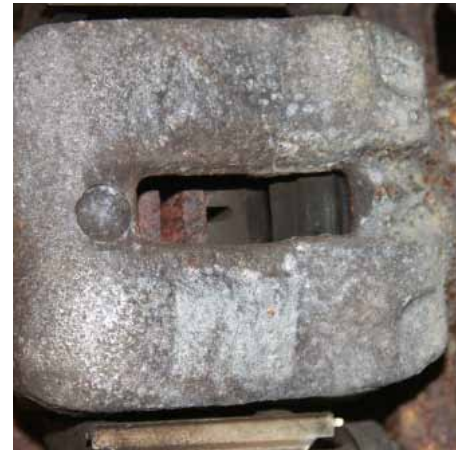
**9** So, girding his loins, Simon set about tackling the timing belt. The first job was to jack up and support the offside front corner of the car and remove the wheel. Taking this opportunity to check the brake pads, they looked like new.

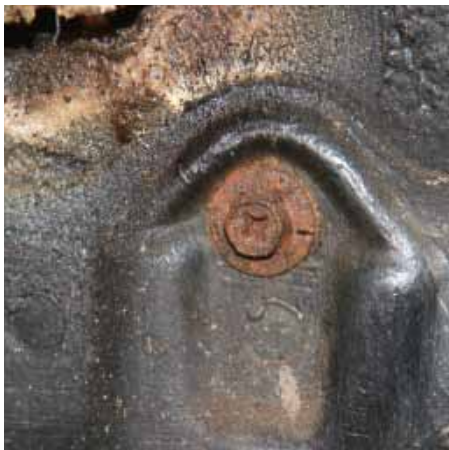
**10** The next step was to remove a plastic splash guard in the wheelarch, which meant that access to the front of the engine was then actually pretty good. This was held on with a mixture of coarse self-tappers like this...

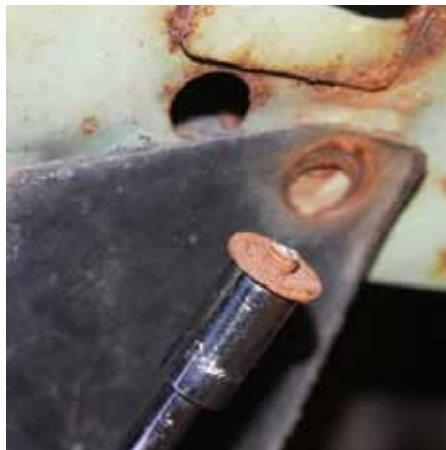
**11** ...and small bolts like this, one of which was even smaller after it snapped off. It went into the beam behind the front bumper, screwing into a captive nut with no access behind, so the remains would have to be removed somehow.

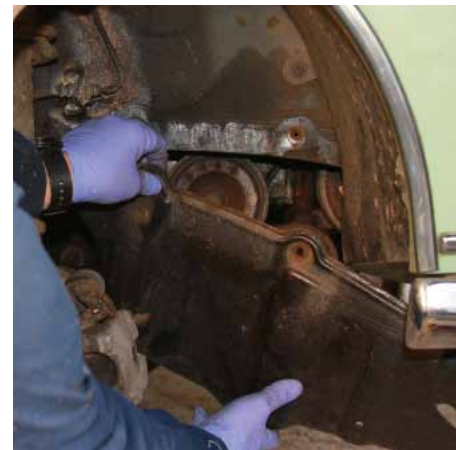
**12** For now though, Simon could concentrate on the task in hand. This is the plastic shield coming away, providing access for much of the work to be done from below and via the wheelarch rather than in the cramped engine bay from above.

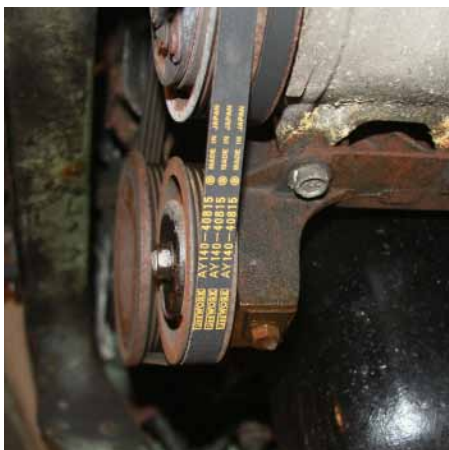
**13** There are three short drive belts (those used to older classics would call them fan belts) on the Figaro, driving the alternator plus the power steering and air-conditioning pumps. We'd bought a new set from The Figaro Shop for £31.48.

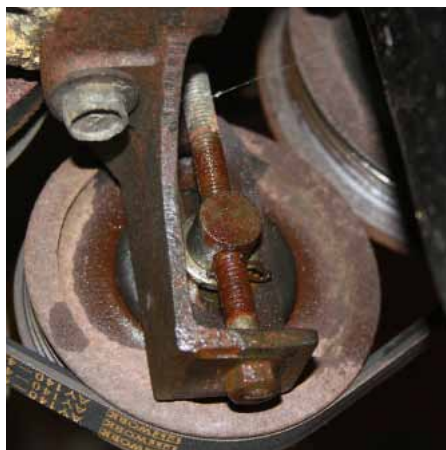
**14** The forum tutorial says about loosening this tensioner's bolt, winding it out and then hitting it with a hammer to slacken the belt. It sounds odd, but once you get in behind and see how the mechanism works, it becomes clearer.

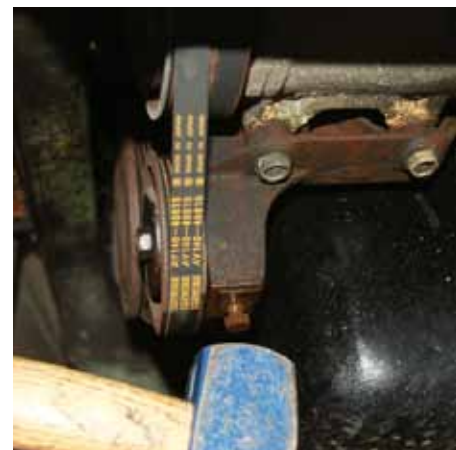
**15** With the bolt unwound, hitting it up moves the tensioner wheel until the belt is loose enough to come off. The first belt is to the aircon pump, while the one behind runs up to the alternator, which slackens off in the normal way.

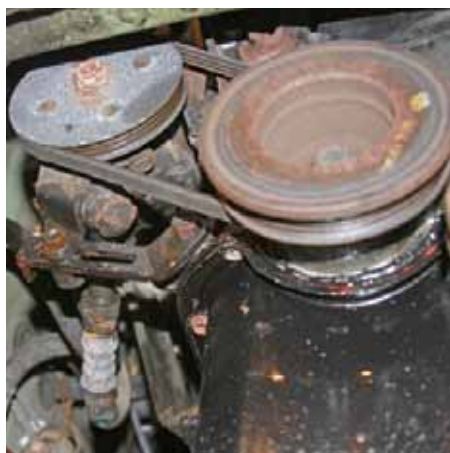
**16** The third belt runs from the crankshaft pulley to the power steering pump. It is clear that we have some kind of leak in the PAS system from the amount of fluid splashed around. We'll add that to the list, then!

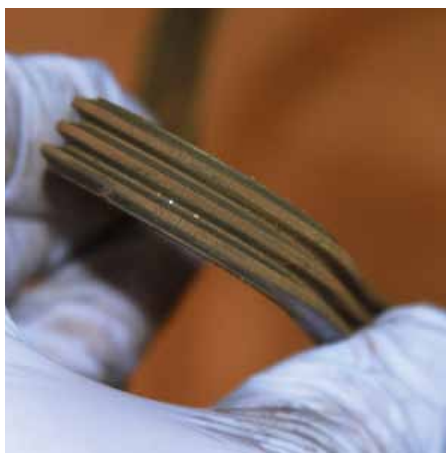
**17** The belts were not badly cracked, but they did feel a little hard and had some small crazing. One was squealing on start up too – this could have been down to an adjustment issue, age or, as we later learnt, because most Figaros do this!

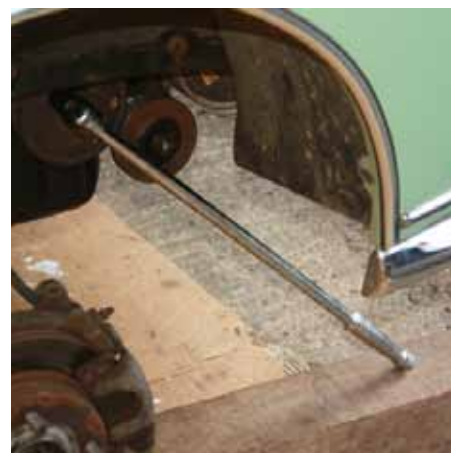
**18** To try and shift the crankshaft pulley bolt, Simon put a breaker bar and an impact socket on it, rested the other end of the handle against the floor and flicked the engine over on the key. There was not enough poke in the starter to shift it.

Personally, changing timing belts is way down on my list of fun ways to spend a day, but it is not exactly rocket science so, after reading a couple of Figaro tutorials online, I decided to tackle it with the help of a friend, Steve Clark, who brought along moral support, an extra pair of hands and also his impact wrench, which we'd been told was essential for getting off the bottom pulley bolt – the problem here is that there is no obvious way to hold the engine still while applying pressure to the nut given that it is mated to an automatic gearbox with a torque converter.

Unfortunately the impact wrench banged away without making the slightest impression on the pulley bolt, but we found other ways to get around the problem, as the pictures show. Ultimately

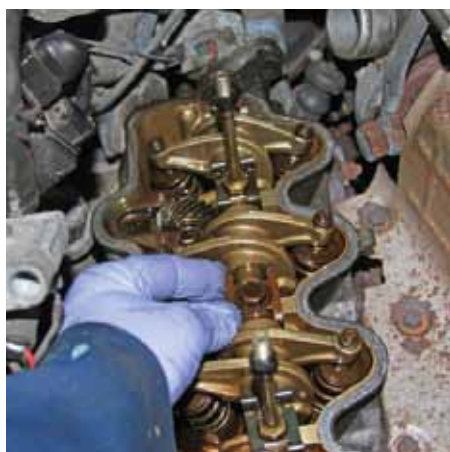
**19** Plenty of head scratching later, he decided to try something he'd read about, but never seen done before. First he took the rocker cover off (and inspected the security of the rocker gear as the securing washers can break)...

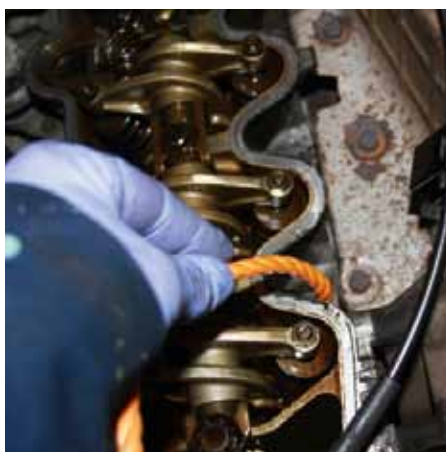
**20** ...then with the engine turned so this cylinder had gone past TDC on its compression stroke and on down to BDC, a length of rope was fed through the spark plug hole and the engine turned backwards, compressing the rope.

a length of nylon rope came to our rescue. Turning the engine over using a ratchet on the crank pulley bolt until the piston in no.1 cylinder was at the top of its compression stroke (meaning that the valves were closed and the rockers not under tension) then continuing 180 degrees on the crank until

the piston was at BDC, the rope was fed in through the spark plug hole.

Next, the engine was turned backwards so that the piston was coming up the cylinder back towards TDC and the previous compression stroke – this meant we were turning the crank anti-clockwise

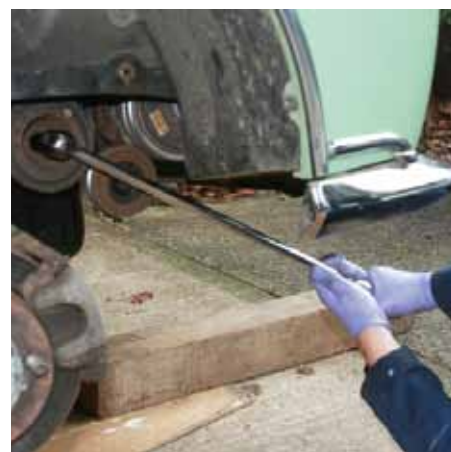
**21** When the piston could not compress the rope any more, it stopped turning and we were able to finally crack the bolt free with the breaker bar and then wind it off with a ratchet spanner. It now didn't seem to need much force at all!

and the valves remain closed as the piston approached and compressed the rope in the combustion chamber above. This did the trick and with a long breaker bar, when the engine stopped turning because it could not compress the rope above it any further, the bolt wound off easily enough.

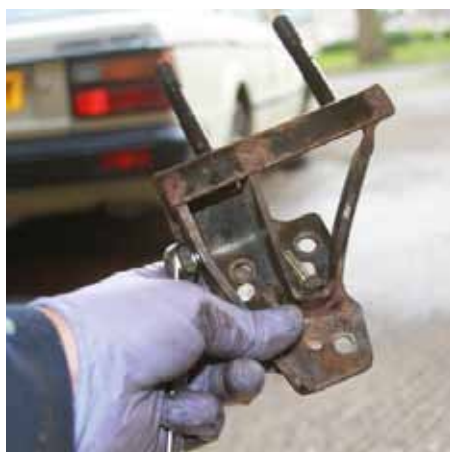
**22** The advice was to remove the RH engine mount as a unit, but we found it easier to take off in two halves for better access to the bolt below. Taking the timing cover off, one bolt had rusted into its steel bushing, but was persuaded out.

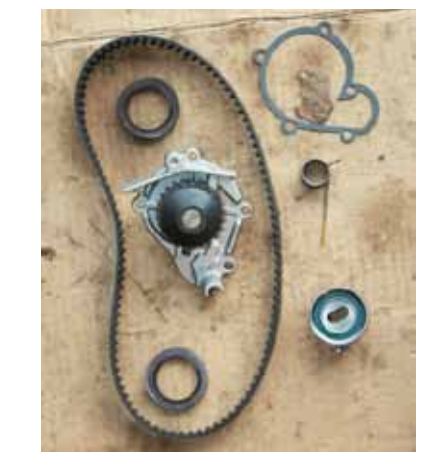
**23** Rather than just a belt, we bought a complete kit for £69.95. This came with a new idler and water pump too – changing the pump at a later date would involve all the same work, so it made sense to carry out a pre-emptive swap.

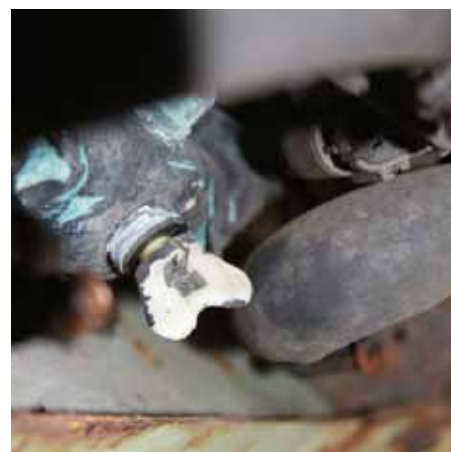
**24** That meant draining the coolant. There is a plastic drain plug in the bottom of the radiator. We learnt later that these can snap and should be used with caution, but ignorance is bliss and ours undid without any problem.

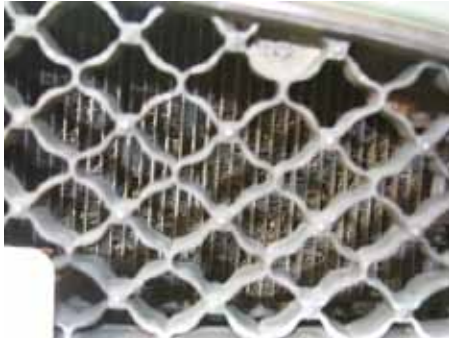
**25** We've bought a new set of coolant hoses, but looking at the radiator through the grille it's clearly in a bad way. That was the excuse we needed to prevaricate – the radiator will have to be changed, so we can do the hoses then.

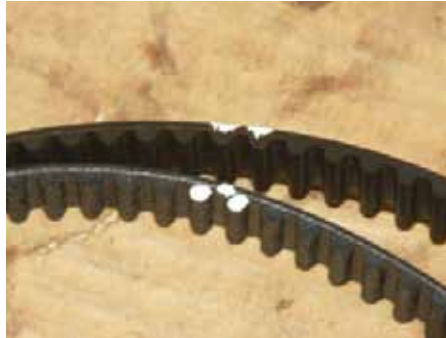
**26** Simon's preferred method of changing a timing belt is to mark the old one with Tippex around the timing marks before it is removed, then counting the teeth between the marks and transferring them to the new belt.

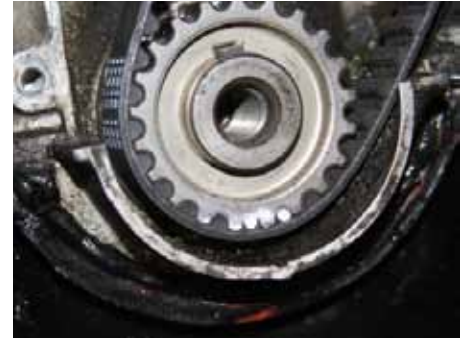
**27** He knows the pulleys have not moved, but by ensuring that the Tippex marks on the new belt are correctly positioned around the timing marks on those pulleys, he then has a fail-safe way of double checking everything is spot on.

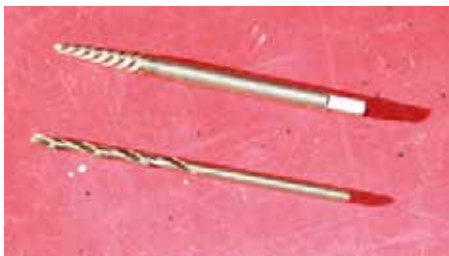
**28** Simon could then turn his attention to the sheared bolt. Drilling a pilot hole and using this stud extractor did not shift the remains...

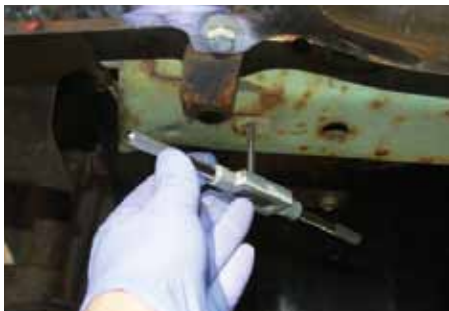
**29** ...so he had to drill out the broken bolt, then run a tap through the hole to clean up the threads for a new one.

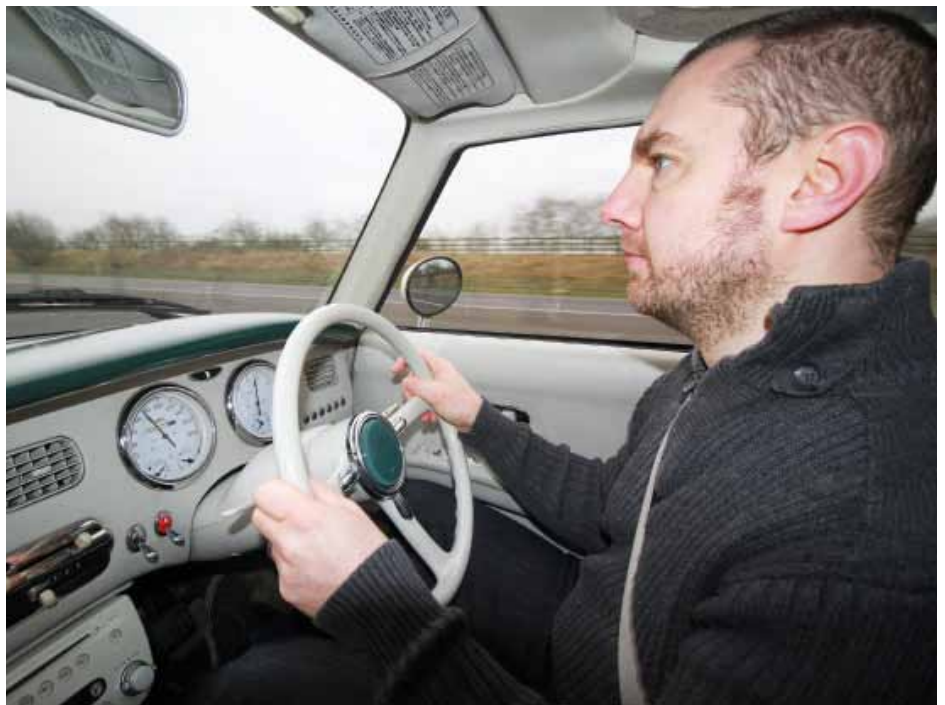
**30** With the car back together and running well, Simon Smith of the Figaro Owners Club took it out for a run and was very impressed with the way that it drove. He also gave the car a thorough check over and helped us prioritise future jobs to be done.
