PROJECT FIGARO PART 4 INTERIOR REFURBISHMENT

We head down to The Figaro Shop in Didcot to get some expert help with one major and several minor improvements in the Figaro's cabin. **REPORT: SIMON GOLDSWORTHY**

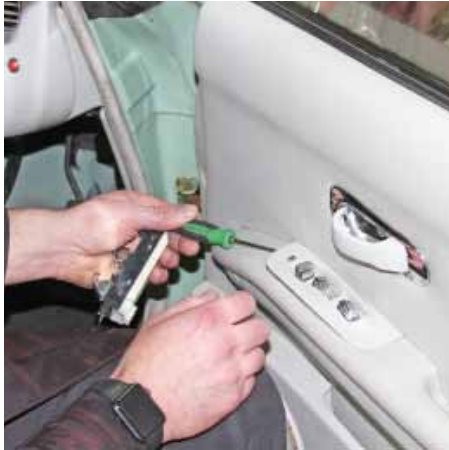
1 One of the jobs on our list was that the electrically-operated window in the driver's door would no longer operate. So Toby flicked out the switch unit...

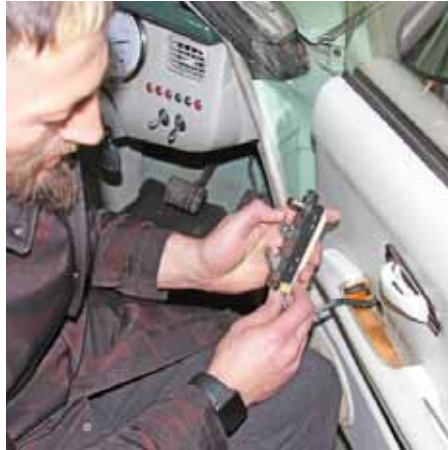
2 ...and tried another switch from their parts shop. That gave the same problem though, namely that we could hear the relay click, but the window did not move.

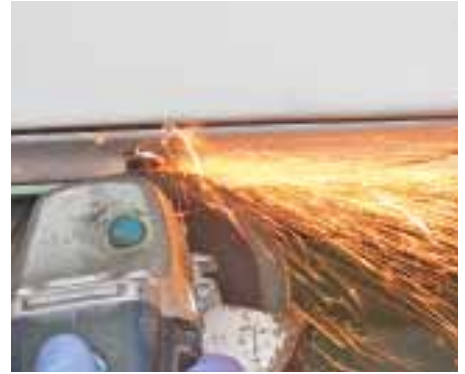
3 So now we had to remove the door card to examine other components in the system. There are four screws in cup washers holding the bottom edge of the door card to the frame. One was so rusted that Ant had to cut a slot in the head and use a flatblade screwdriver to turn it out.

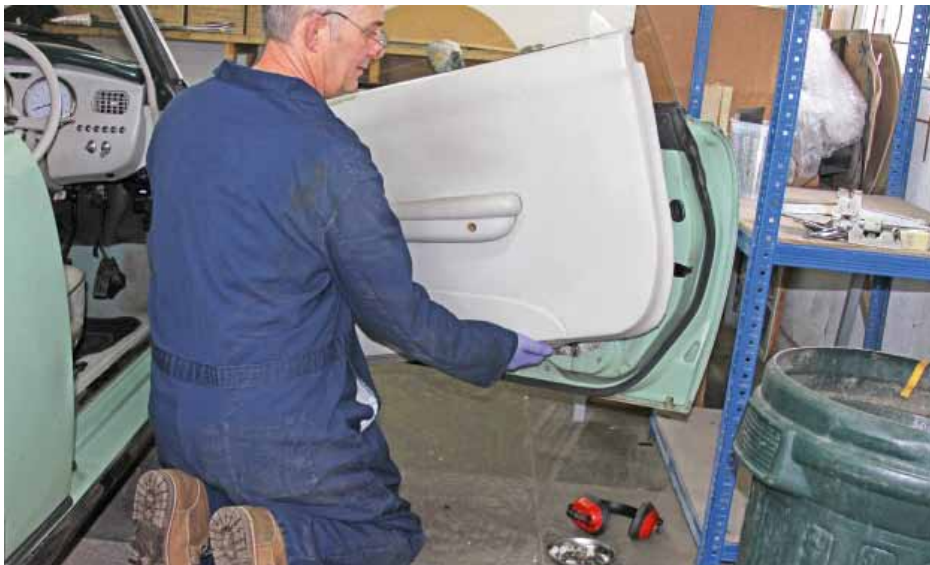
4 The card could then be levered out of the retaining clips and twisted up and out after removing door pull and handle screws and disconnecting the window switches.

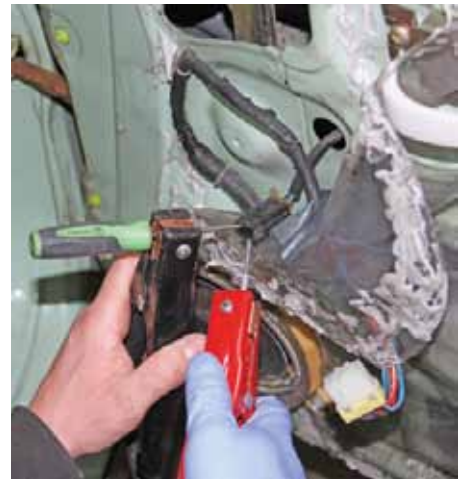
5 Now we could test the window motor, but running power directly to it had the window opening and closing on demand. So the only suspect left was the relay box.

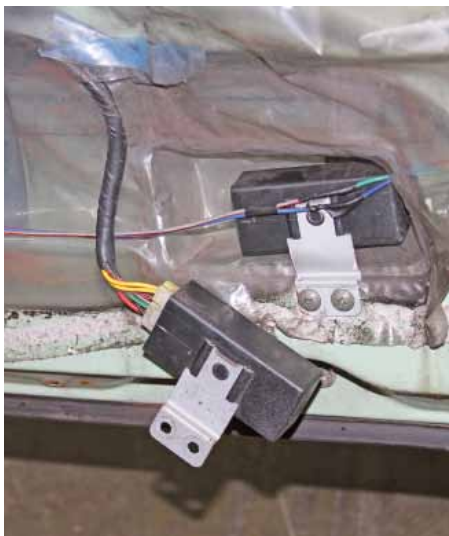
6 The contacts on this can corrode, but it is very hard to open and close the unit to access them for cleaning. So we tested it by substituting another relay. That did the trick, and that was duly fitted.

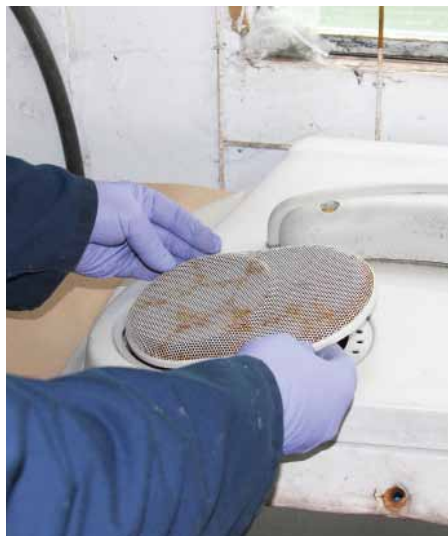
7 We needed both door cards off anyway because the speaker grilles had gone rusty – this is another common Figaro problem. With time at a premium, we removed the old grilles...

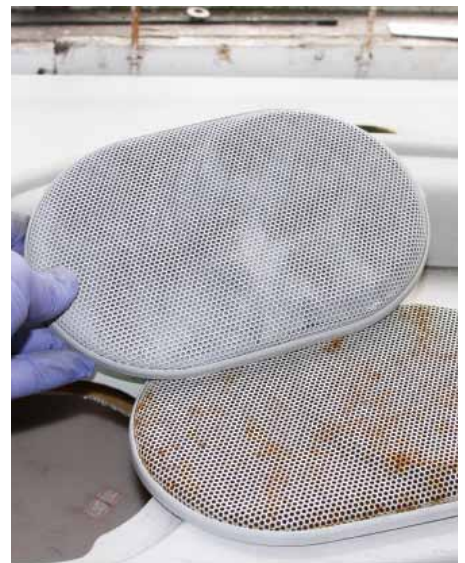
8 ...and replaced them with a refurbished pair from The Figaro Shop's shelves. Little details like this can make a big difference to the whole feel of a car.

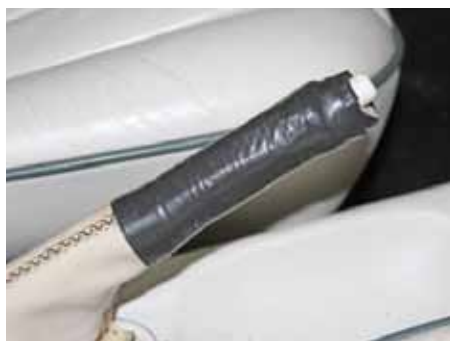
9 As did the handbrake! It came to us wrapped in insulating tape like this and just felt so wrong, even though we had no way of knowing what was underneath.

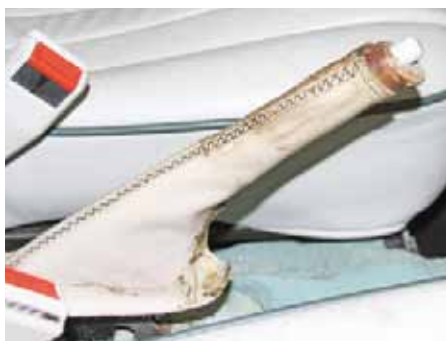
10 Cutting off the tape revealed this vinyl cover. I didn't realise at the time, but this was a home-made addition to cover a plastic lever that had decayed.

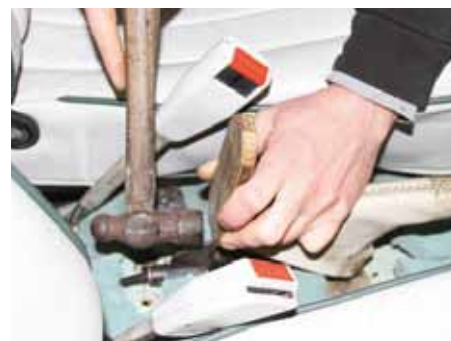
11 Ant showed us how the entire plastic and vinyl handle was simply knocked forwards and off the handbrake lever itself using a protective block of wood...

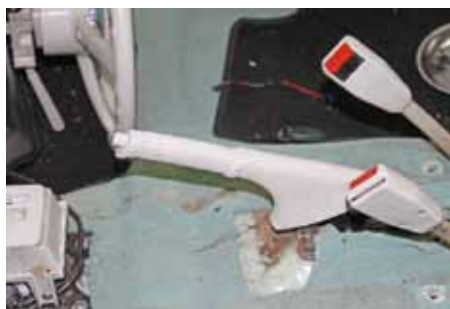
12 ...while a secondhand replacement from the stores was bought and knocked back on. As you can see from this picture if you look closely, this was fitted later because first...

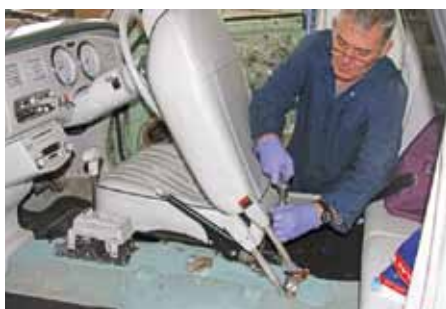
13 ...we took out the plastic surround to the gearstick and handbrake lever (four screws and the lead to the power socket) followed by the front seats to create more room.

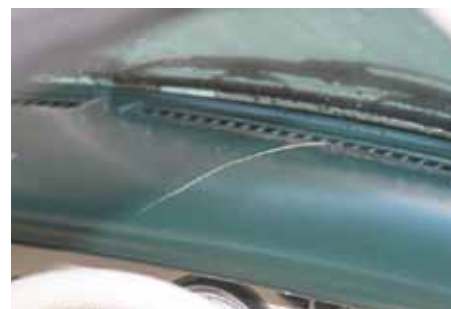
14 That's because the dash on our car had been painted in the past and finished very well, but it had cracked badly ahead of the driver and we wanted to replace this with a new leather cover.

tasks we were planning was to change the top of the dash. This is notorious on the Figaro for cracking, and our car had a split of epic proportions right ahead of the driver. This did not affect the way the car drove of course, but it did let down an otherwise fairly tidy interior. And since The Figaro Shop offer a leather-covered replacement for £350, we had ordered one of those.

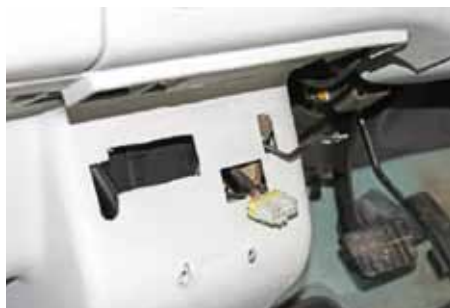
15 The stereo unit that can be seen in the picture with Step 13 was next to come out. Again the screws were easily visible, and this was followed by this lower fascia panel behind it.

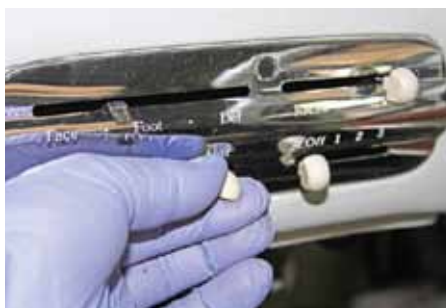
16 The heater knobs pulled off, then the chrome surround to the levers could be removed. After releasing the screw holding the lever box to the fascia, Ant pushed the levers away.

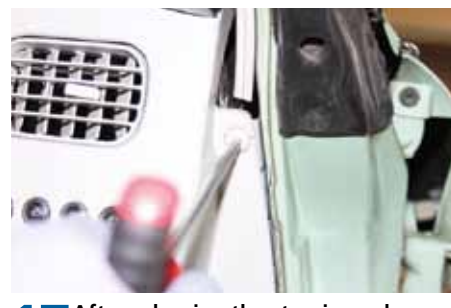
17 After releasing the steering column and lowering it to the floor to create more space and also removing the plastic side panels across the cant rails, attention turned to the two Torx screws at either end of the dash assembly.

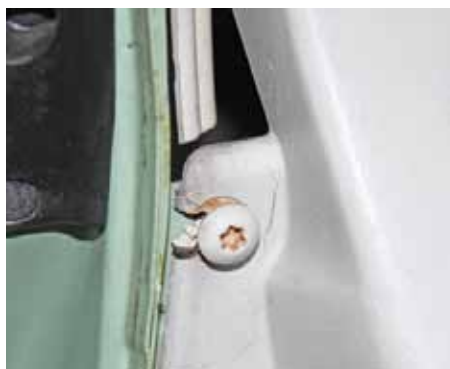
18 You have to go easy when undoing these Torx screws as they can stick to the dash – ours was already cracked and crumbling on the nearside.

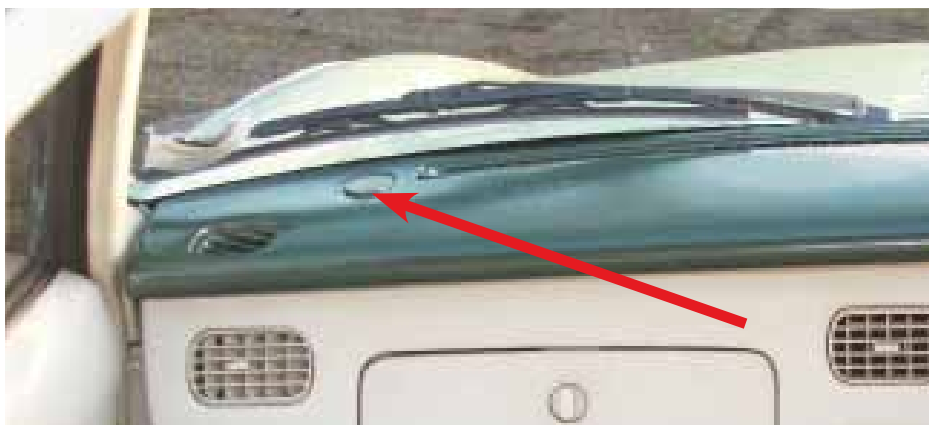
19 There was also a 10mm nut at each end under removable covers in the dash top. However, before releasing these, Ant disconnected the speedo cable...

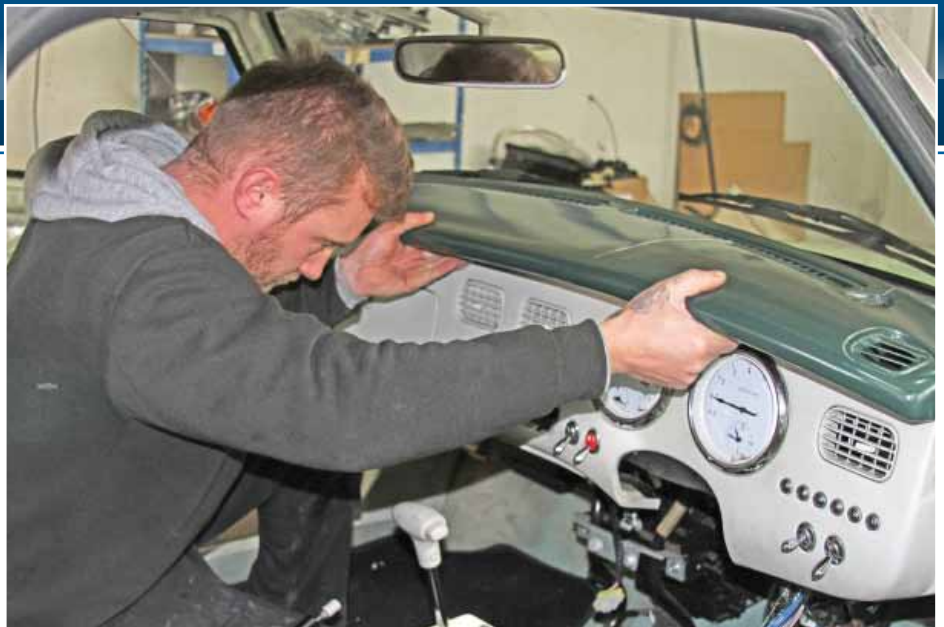
21 Finally the dash could be manoeuvred out of the car and laid on a padded bench. Note that the rev counter has for some strange reason stuck at 1000rpm!

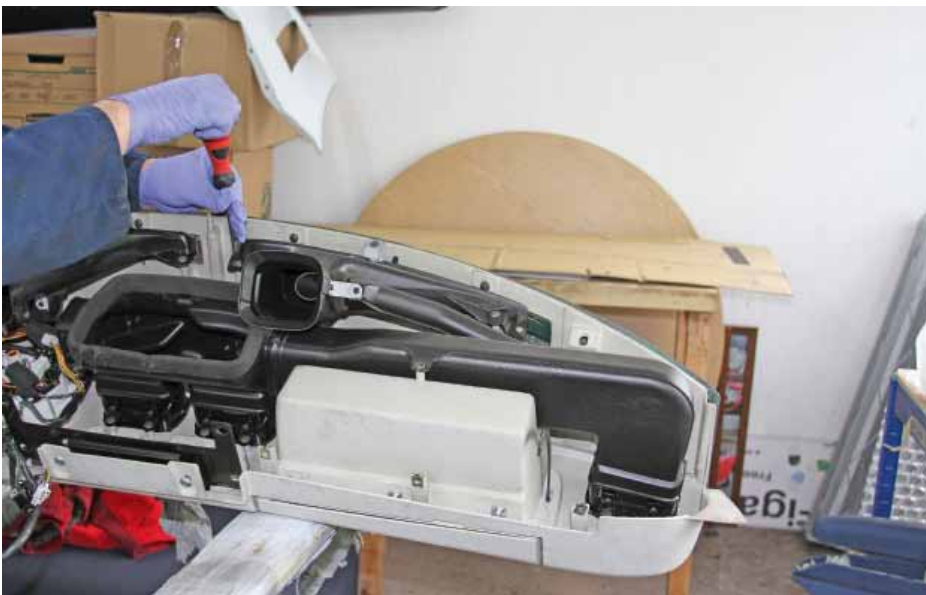
22 Enjoying the comfort of now working on the bench, our next task was to remove all of the plastic pipework for the heater and fresh air circulation system.

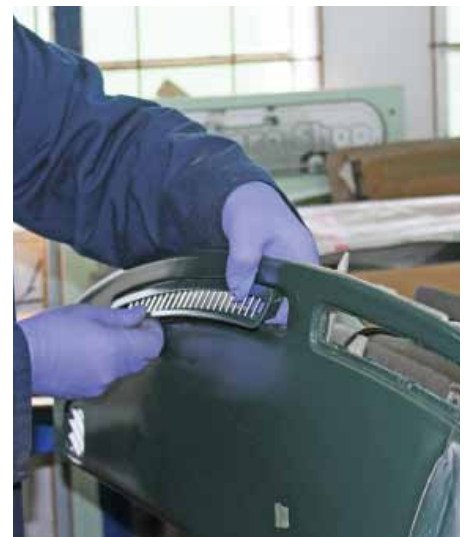
23 Before undoing the many screws holding the green dash top to the dash itself, we had to carefully pop out these grilles, which are easily damaged.

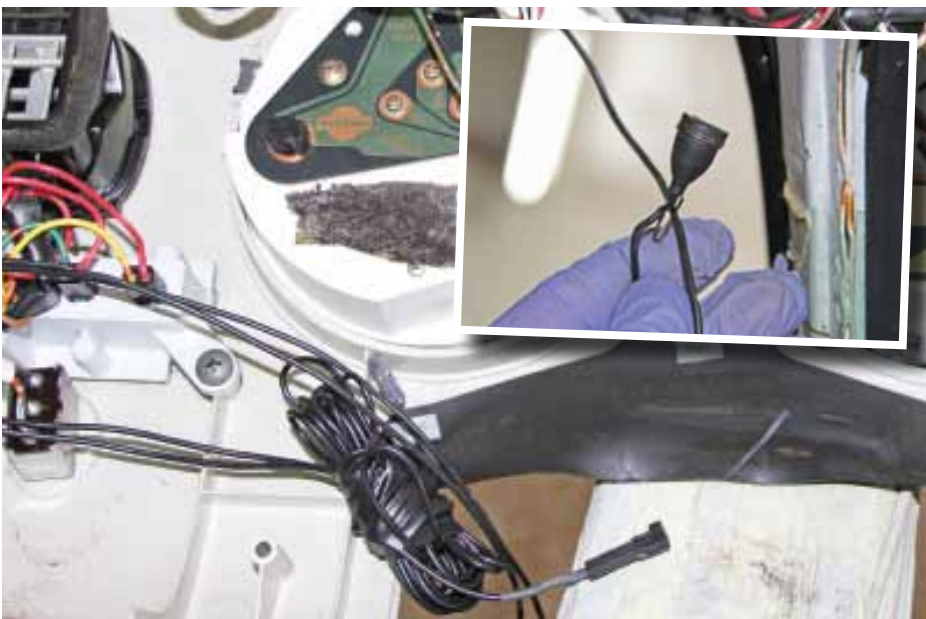
24 Aftermarket alarms are often more trouble than they are worth, so we also took out miles of alarm wiring and the microphones. The alarm's 'brain' had already been taken out on our car, so it was not working anyway.

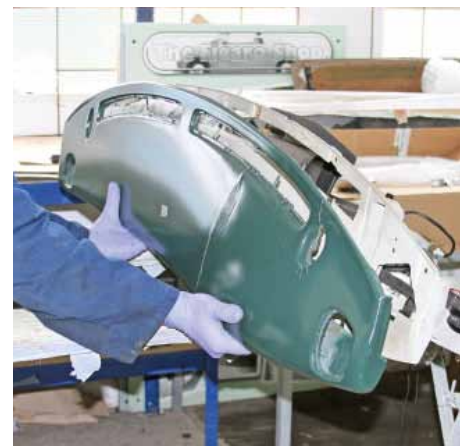
25 Finally the dash top itself could come off. We were surprised to discover that it was actually metal underneath and the crack was only in the top shell.
