FIGARO PROJECT PART 5 DASH, SEATBELTS AND LEDS

Picking up from where we left off last issue, there is a little more disassembly to do on the Figaro's interior and a couple more repairs to make before we can put it back together for the drive home.

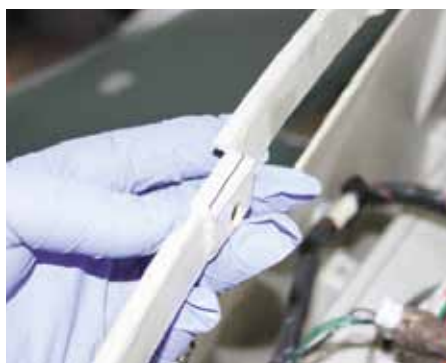
1 The plastic dash structure itself is quite brittle, presumably not reacting well to the aging process. Ours was cracked in a couple of places, but this break was not in a critical position.

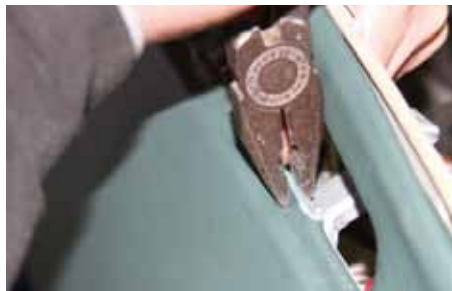
3 Note that Ant had very carefully trimmed the leather with a sharp craft knife in a couple of spots because otherwise the added thickness of the leather cover...

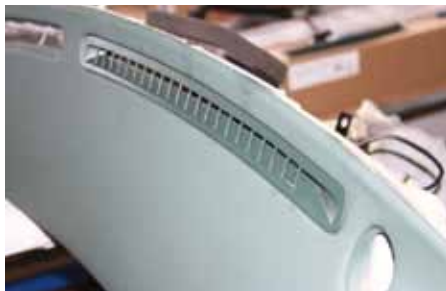
4 ...would have made the gap too narrow for the plastic demister vents to clip into place. These are quite vulnerable where the thin cross-piece vanes are located, so you don't want to force them.

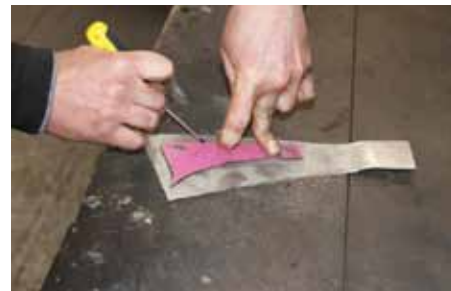
5 We saw last issue how the plastic dash was crumbling slightly at the ends where it was secured to the car. This is so common that The Figaro Shop have a template for repair sections in this area.

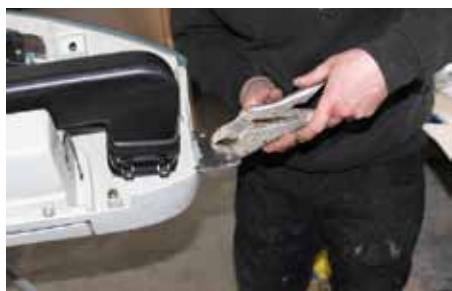
6 So Ant made up a metal reinforcing plate and glued it across the whole area using a two-pack adhesive. We left it overnight to cure before reassembling.

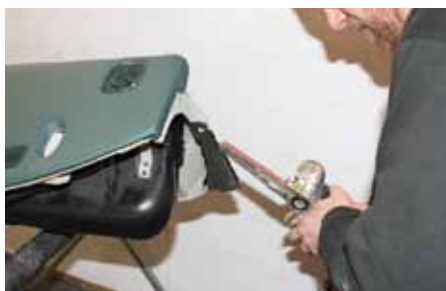
7 This area is quite a tight fit against the screen pillar, so once the adhesive had fully cured, Ant sanded off any excess that had been squeezed out.

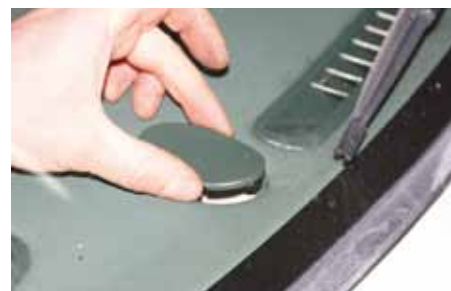
8 Reassembly then really was a reversal of the dismantling process, though the cover at either end over the securing nuts and studs had to be stuck down with silicone because of the thicker leather.

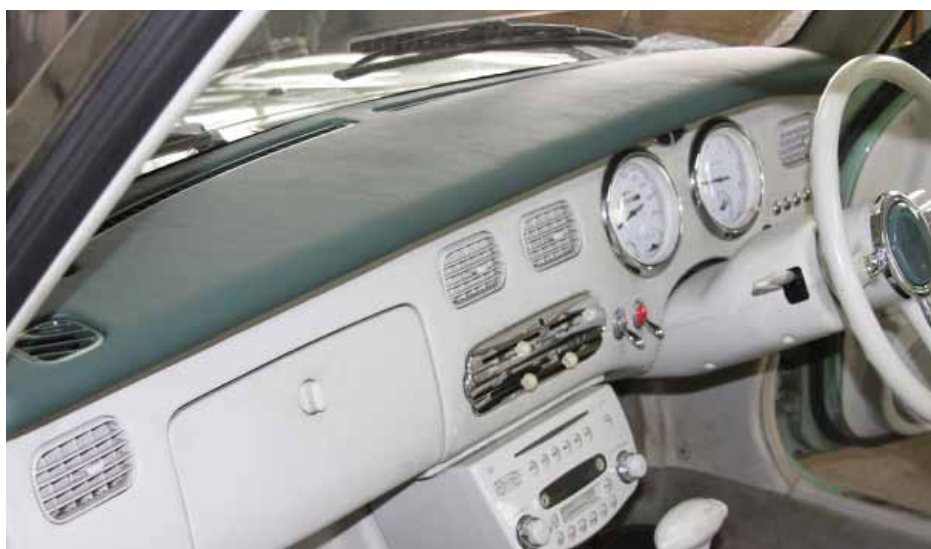
9 We are getting ahead of ourselves slightly, but this was the dash after everything had been refitted, adding a touch of class to what is already a very upmarket interior.

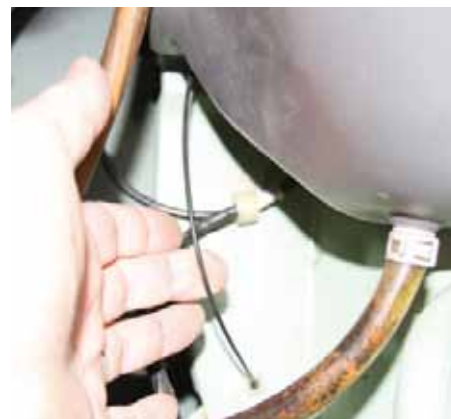
10 Meanwhile, we had tackled that sluggish seatbelt. The hood storage cover catch is electrically operated, but you can also release it by tugging on a cable on either side in the boot.

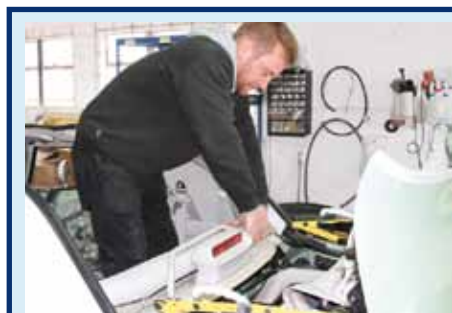
11 That gave good access for removing the rear seat. The back panel has two screws at the bottom, then pulls out and up, but these locating pegs were very tight.

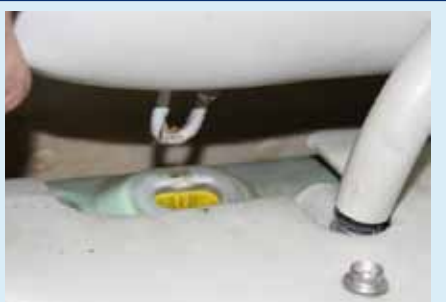
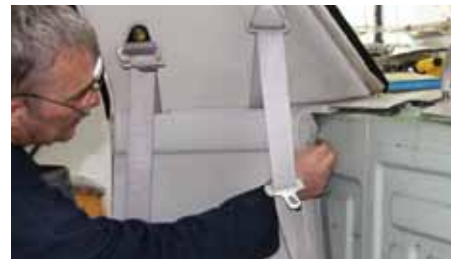
12 With the seat out, we could then remove the side panel which covers the seatbelt mechanism, having already removed the plastic cover across the top of the door opening.

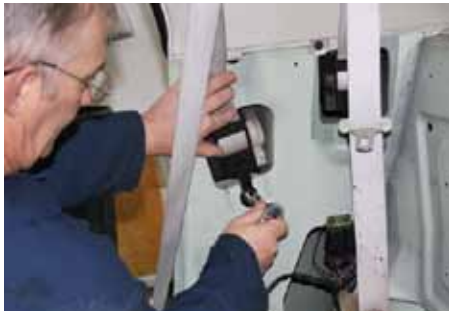
13 All of this was to gain access to the mechanism itself. Before removing it, we did make a precautionary check that the locking mechanism was working correctly by tugging sharply on the belt.

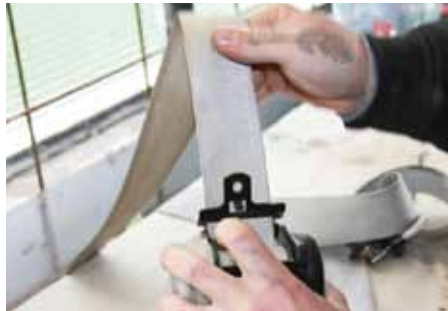
14 With the seatbelt and its mechanism on the bench, the first job was to pull the belt out as far as it would go. A bit of fabric cleaning wouldn't go amiss, but that can be done later on the car.

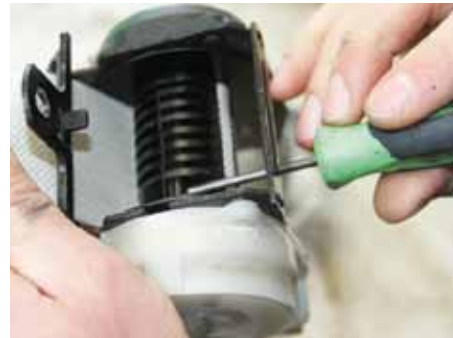
15 With the seatbelt unwound to its full extent, the mechanism was under tension and trying to pull it back in, so Ant pegged it with a pick through this hole.

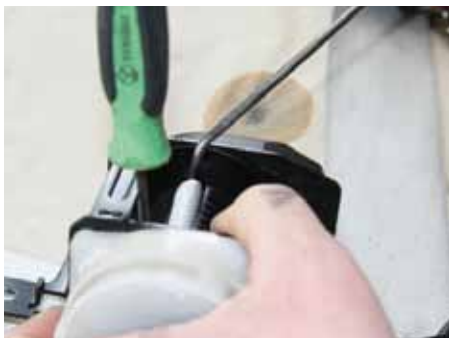
16 With the spring pressure removed from the equation in this way, the end of the seatbelt could then be prised gently from the spindle with a second pick.

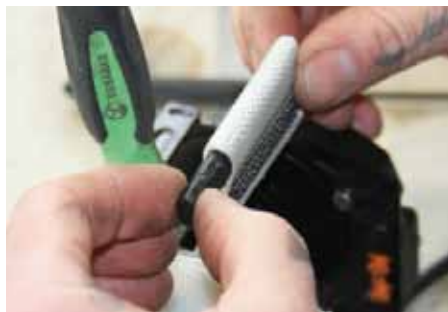
17 Taking great care not to damage the material with the pick, the plastic end through the belt's loop could be removed and then the belt pulled through the other way and out of the spindle.

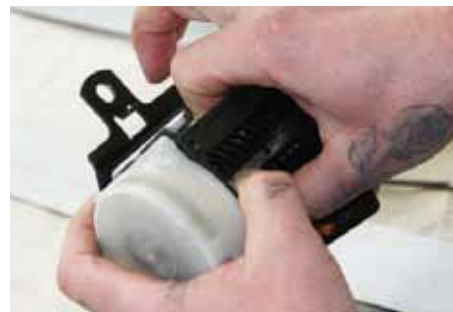
18 Turning the spindle against the spring pressure without the belt inserted meant that the retracting pressure could be increased, but we didn't want to make it so tight it was uncomfortable.

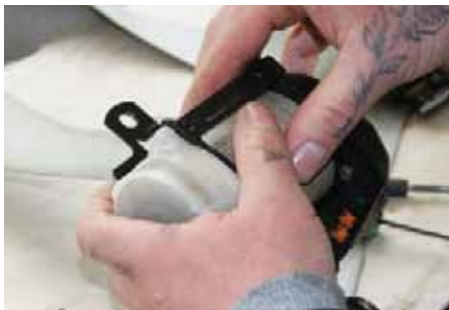
19 Ant decided that one full rotation of the spindle was all that was needed, then he threaded the belt back through, inserted the plastic plug and wound it all carefully back in.

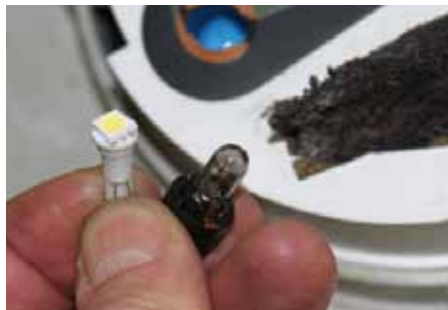
20 One final job to be done at this stage before we could begin putting the Figaro back together was to replace the bulbs in the dash instruments with brighter LEDs. As well as the six instrument bulbs...

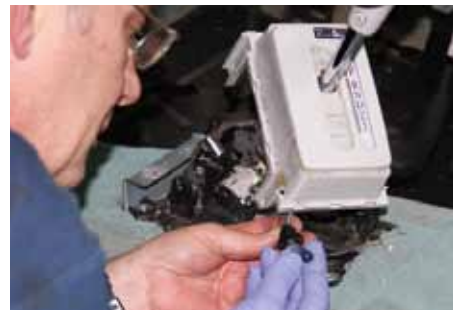
21 ...there was also one for the gear selector and another for the aircon. LEDs only function in one direction, so we reattached the battery and checked they worked before final reassembly.

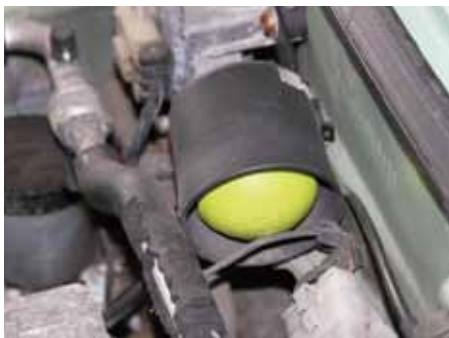
22 We had already removed the wiring and microphones to the non-functional aftermarket alarm, and now we could remove the alarm's siren from under the bonnet too.

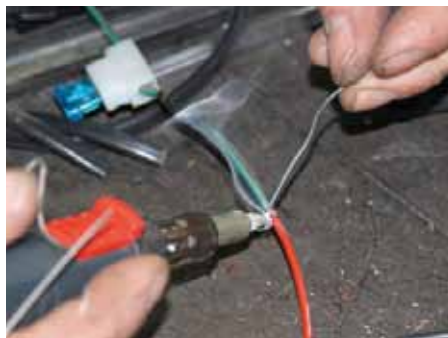
23 Unfortunately the rear fog light that had been fitted when the car was imported to comply with UK regulations had taken its feed from the alarm wiring, so Ant had to solder in a new feed.

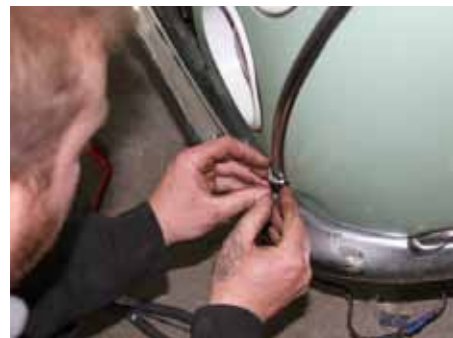
24 And finally, we were missing the shield-shaped piece of trim at the back of this brightwork. Fortunately The Figaro Shop had a new replacement on the shelves and it clipped into position.
