FIGARO PROJECT PART 6 HEAT, COOLING AND MORE

A new radiator and replacement coolant hoses had long been on our Figaro's project list. Unfortunately, fitting them did not go entirely to plan. REPORT: SIMON GOLDSWORTHY

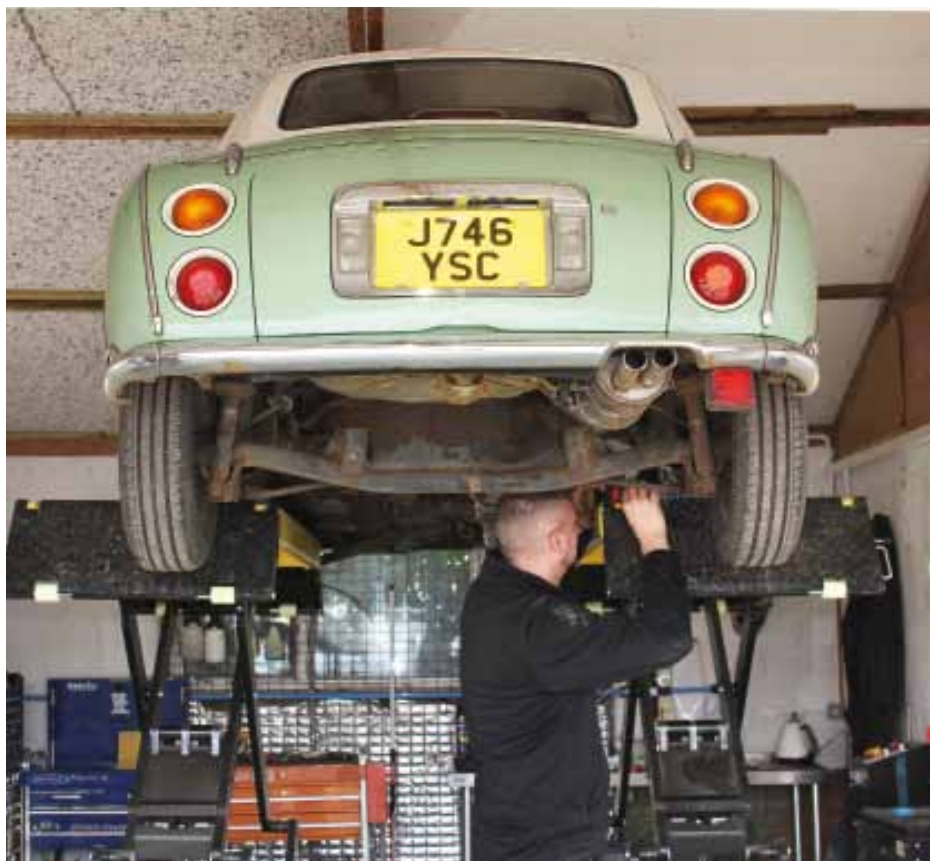
1 The Figaro Shop's Workshop Manager, Mark White, put our car up on the ramp to give it a once over. One of the things he pointed out was that the bush on this gearbox inhibitor switch had broken up.

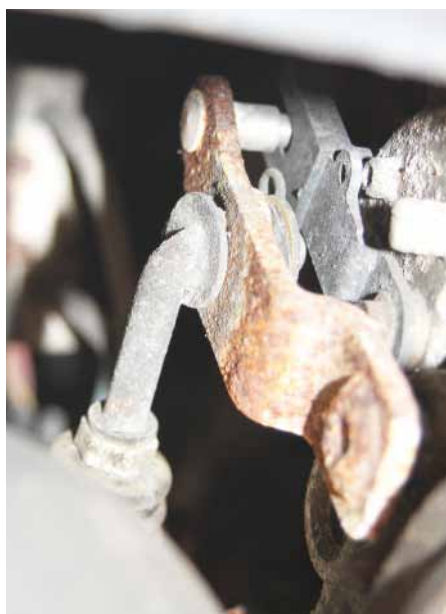
2 With the rod free to move around, the Figaro's electronics could be fooled into thinking the car was in Drive rather than Park and refuse to start. A new bush was cheap enough and relatively easy to fit.

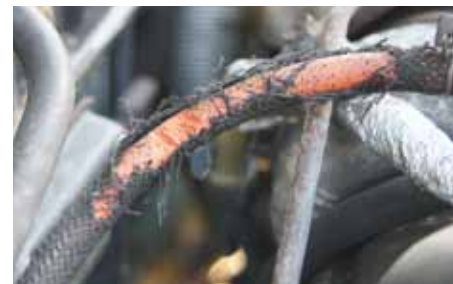
3 This radiator bleed hose had been badly chewed by mice. If this one was in such poor condition, how could we be sure of those that were hidden from view? That's why they all had to be changed.

Next to come off was the expansion tank, which needed a good clean. This was followed by the top hose, together with the small breather hose that had in some ways been the catalyst for this whole operation after being chewed by mice. The fan assembly is held to the radiator by four bolts, and the radiator is in turn held to the front panel by four more. They can be removed as a unit, but I decided to take the fan out on its own first so that I had a better view of the radiator fixings from both above and below. It was so tricky to do this way

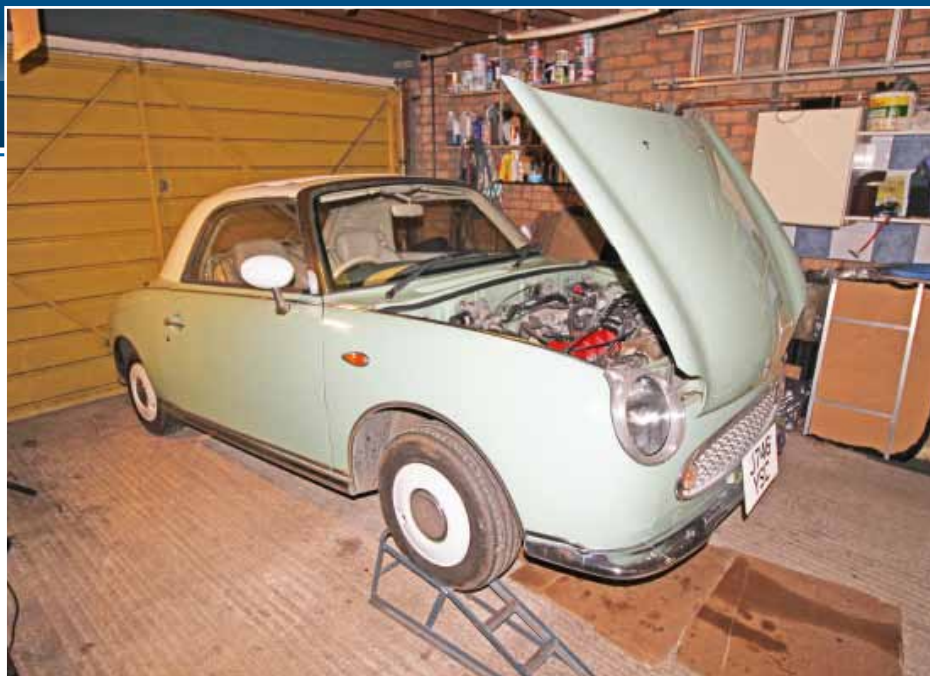
4 Back home, the Figaro was lifted rather than driven onto ramps, which explains how one was placed the 'wrong' way round to ensure the car could not roll off by accident.

had not put a chock behind the rear wheels, and the tyres on the American leviathan were too big to sit safely on the UK-scale ramps. Since then, I have always preferred to jack a car up and push the ramps under the wheels with one facing forwards and the other backwards. This looks a little odd, but means it is impossible for the car to roll off no matter how much I shake it. I feel happier with a car like this even if it is on tiny 12in wheels like the Figaro.

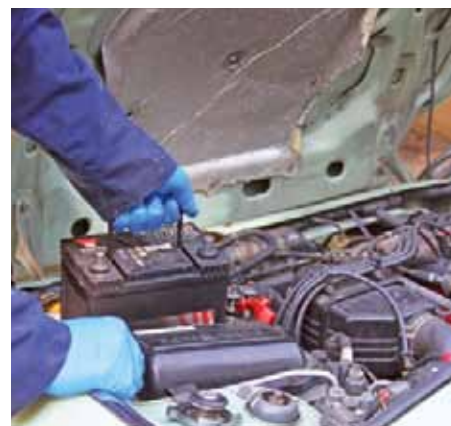
5 The engine bay is so cramped that items had to be removed one at a time to gain access to the hoses and the radiator. Removing the battery was a safety measure as well as to provide elbow room.

After draining the coolant, I next wanted to take the battery out. Partly this was because I would be leaning over to work in the engine bay, and I wanted to remove

any danger of dropping or inadvertently putting down a tool which might short out across the terminals. The battery had to be disconnected anyway because with all that rummaging in the engine bay to remove hoses and the radiator, there was a risk of moving live wires or touching live connections. It also improved access on the nearside. With the battery out, I could see that the battery tray underneath was covered in surface rust. It was not structurally affected, but was unsightly. Since this was bolted to the chassis rail rather than welded, I took the tray out as well for repainting, and to inspect the state

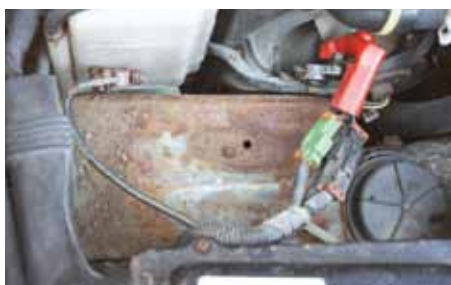
6 This showed that the battery tray had plenty of surface rust. The tray itself was painted grey rather than body coloured, and was secured to the chassis rail with bolts. The rail beneath was sound.

of the chassis rail beneath – fortunately this was sound and the paint was intact.

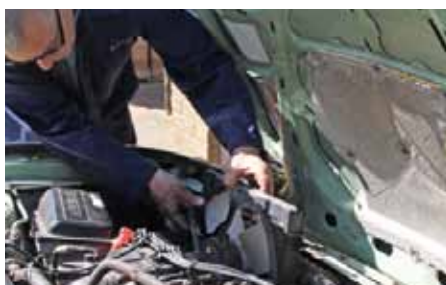
7 Simon took the fan assembly off the radiator while it was in the car. That gave greater access and visibility to study the task in hand, but made the removal more difficult than it needed to be.

« though that when the new radiator goes back in, I will attach the fan to it first.

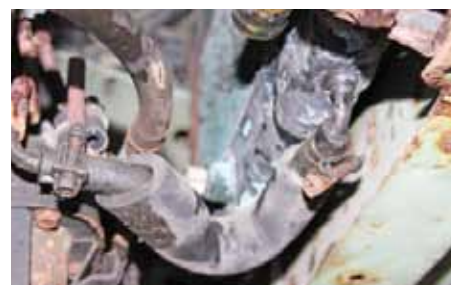
8 There is an oil cooler in the bottom of the radiator for the gearbox oil, pictured here from underneath the car. The rubber pipes to this are simply a push fit held on with regular hose clamps.

I now had easy access and clear sight to reach and remove the bottom hose. However, the Figaro also has a gearbox oil cooler in the bottom of the radiator. This is serviced by two pipes that are simply a push fit secured with hose clips. The rubber oil pipes are connected to two metal pipes, which in turn feed into the gearbox via banjo bolts. These pipes were a bit rusty, but didn't look beyond saving.

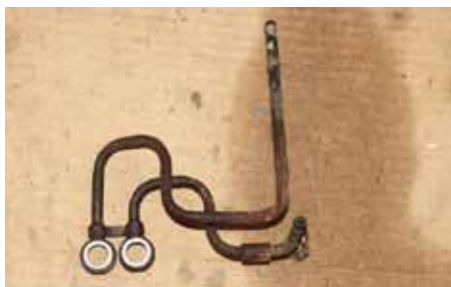
9 The other end of those rubber oil-coolant pipes attach to this steel pipe assembly which in turn is secured to the gearbox with banjo bolts. The metal pipes were rusted, but not terminally so.

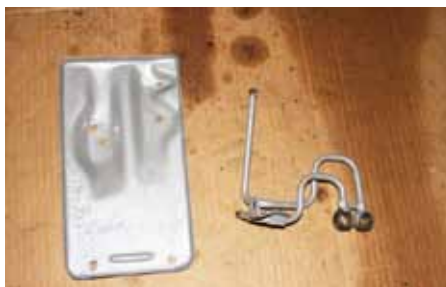
10 Simon had the battery tray and the pipes blasted and powder coated, after first wrapping the unions in tape to protect them. The blasters used a low pressure on the potentially delicate pipes.

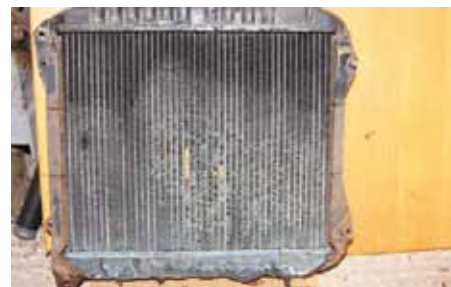
11 The old radiator came out with just one sheared bolt. It really was in a very sorry state, with large sections where the cooling fins had disappeared and others falling off at the slightest touch.

With all this out of the way I could finally remove the radiator. Unfortunately, this is held on by small M6 bolts with 10mm heads and despite my best efforts, one bolt on the nearside sheared. Sod's Law dictated that there was not enough room in the engine bay to get a drill in to take out the remains. In the end, my flexible drill drive came to the rescue, as there was just enough room to get this in and work progressively up through the bit sizes until I could get an M6 tap in and clean out the thread.

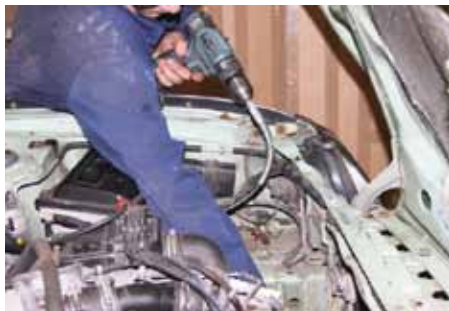
12 With access in the engine bay so tight, not even a compact cordless drill could get in to tackle the sheared bolt. Fortunately a flexible drive made it just about possible to drill out the remains.

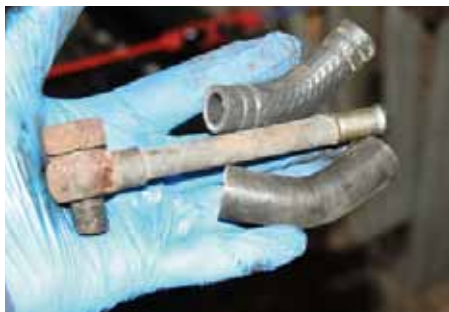
14 In such cases, the answer was to remove the metal section too and fit the hose off the car. One thing that did impress on the Figaro was how easily things undid. Well, nearly everything...

Both of these take-off points had very short lengths of hose that connected them with further metal pipes, and the problem was that I didn't think there would be enough flexibility in such short lengths to manoeuvre the old ones out and the new ones in. There was no option but to take the downstream metal pipes off as well. The one up to the turbo was easy enough, being secured with an easily accessible 24mm banjo bolt. The one running back to the heater was a nightmare though, with a single 10mm bolt holding a bracket to the engine with very difficult access.

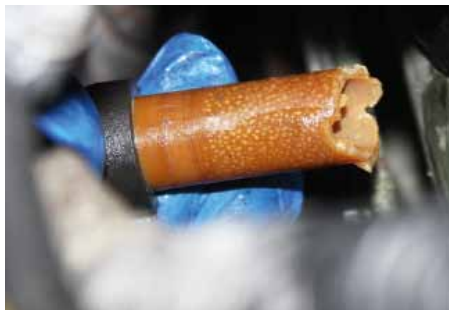
16 Unfortunately, with the end of the job in sight, one of the plastic stubs from the heater matrix broke off. This was a disaster, as replacement would mean taking out the dash. Again.

Having now disturbed the pipe running to the heater, I tackled the feed and return hoses to that next. These attach to stubs that exit the heater matrix through the front bulkhead. The one on the nearside came off easily enough, but this revealed that the stubs from the heater were plastic, not metal as I had expected. And not fresh plastic, but browned stuff that looked aged and brittle. So when the clip on the offside hose started to twist as I undid it, instead of forcing the thread I cut the wire with snips. It was all to no avail though, because when I took hold of the hose to see if it would move, it came away from the car with the

now broken plastic stub still attached.

I have to say that I showed remarkable self-control, not swearing at my luck or throwing things around the garage, but instead tidying my tools away and calling it a night. Why do I say that this was impressive? Because instead of being almost ready for a straightforward reassembly of the cooling system, I was now faced with removing the entire dash so that I could change the heater matrix. And I had only just taken the dash out to replace the top with a new leather-clad item, so this would be repeating a full day's work. I did think about bypassing the heater for now, joining the two hoses with a length of copper pipe I had, but the stubs were 16mm outside diameter, so the 15mm

copper pipe would not have been a tight enough fit. Whoever decided that plastic was a suitable material for the heater, given its inaccessible location and the fact that it would go through thousands of heating and cooling cycles, really should take a long hard look at themselves in the mirror... **CM**

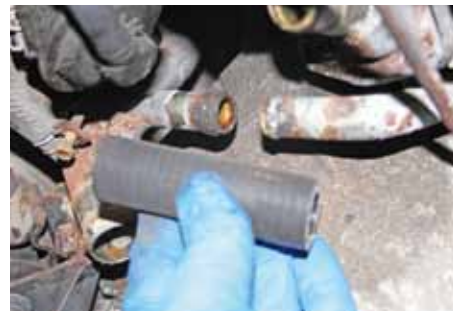
13 Some of the new hoses were so short that there was no way they'd be flexible enough to squeeze between the two metal pipes when the gap between the ends was as narrow as this.

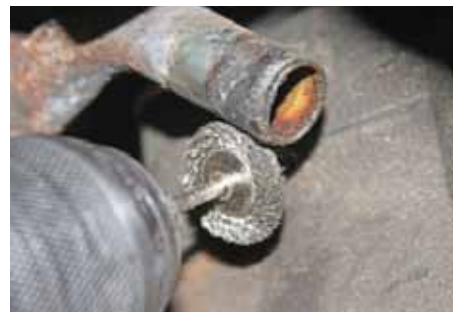
15 Most of the metal pipe ends were in good shape, but one had a build-up of paint and rust that promised to make getting a leak-free union difficult. Cleaning up with a wire brush in the drill solved that.

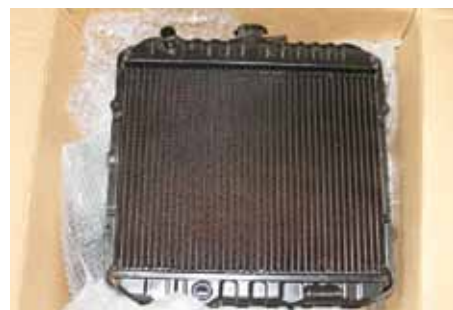
17 Meanwhile, the reconditioned radiator had arrived. We had to return our old unit as an exchange to avoid paying a surcharge, common practice with many reconditioned items.
