FIGARO PROJECT PART 7 REPLACING THE HEATER MATRIX

The Figaro's interior has to come out once again, this time to replace the heater matrix after one of its plastic outlet pipes snapped off when the hoses were being changed. REPORT: SIMON GOLDSWORTHY

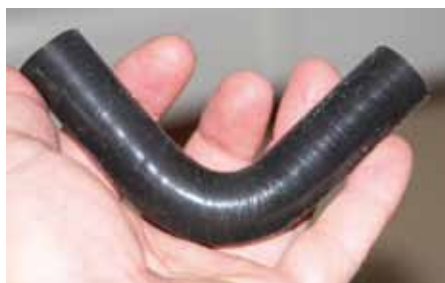
1 The Figaro squeezes a lot of equipment into a small engine bay, and it was hard to decide exactly where this hose in the new coolant pipe kit should go. Fortunately, a quick phone call to The Figaro Shop provided the answer.

The next day found me back out to the garage to finish the prep work before ordering the parts I needed. This involved tracing the remaining coolant hoses, a task made more difficult by the fact that there were plenty of breather pipes which were the same size and shape as one short 90° bend (thanks to the guys at The Figaro Shop for helping me identify the correct one over the phone!). The silicone hose kit had been

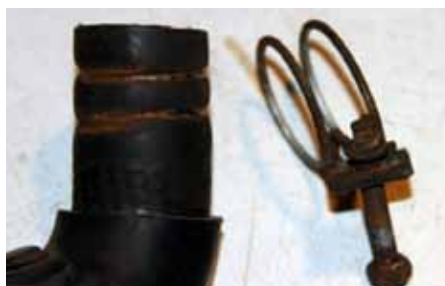
3 Nissan used twin-wire clamps on all hoses, but these do tend to cut into the rubber when tightened. Simon was happy to reuse them on low-pressure air feed hoses, but used genuine Jubilee clips on the new coolant pipes instead.

expensive, but I must say the hoses all fitted beautifully – they were a snug fit on their respective pipes, but only needed hand pressure to slide them into position and no lubrication. As for the genuine Jubilee clips, these tightened easily, squarely and firmly and were a pleasure to use. Sometimes, you really do get what you pay for.

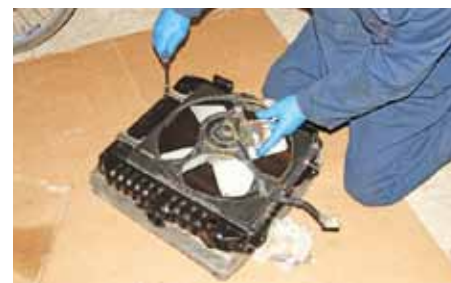
2 Although the best advice is generally to always replace everything in the same order as it was removed, Simon decided that it had been a mistake to remove the fan before the radiator and so they were refitted as a unit.

It is generally good practice to reassemble things in the reverse order to the way you took them apart, otherwise it is all too easy to find out that part C obscures access to part A, and everything has to come back off so you can do it again. However, after a good look around I was pretty confident

that taking the radiator fan off before removing the radiator itself had made the job unnecessarily complicated because of poor access, so I put it back on the radiator before refitting the whole lot as a single assembly. Fortunately, this worked fine.

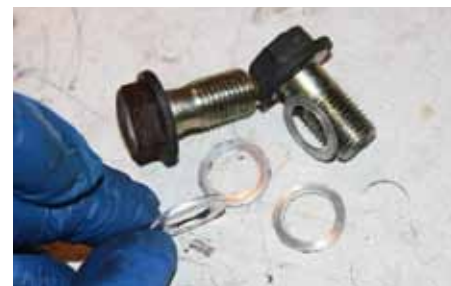
4 Simon managed to lose one of the washers used to seal the oil coolant pipes to the transmission. Fortunately he had some new MG ZT sump washers that were a suitable replacement. Later, of course, he found the original washer!

There was one other missing item that was down to my carelessness. You may recall that I had removed two steel pipes that took gearbox oil to the oil cooler in the bottom of the radiator, and sent the pipes away for blasting and powder coating. These pipes were secured to the

transmission with banjo bolts, which had thin aluminium washers on either side of the unions. When I came to refit them, one washer was missing. Fortunately I had some MG ZT aluminium sump washers on the shelf that are exactly the same ID and OD, but 1.85mm thick instead of 0.95mm. I used two of these on the gearbox side of the banjo unions so that the feed holes would be in the correct place, reusing two of the thinner originals on the other sides. **CM**

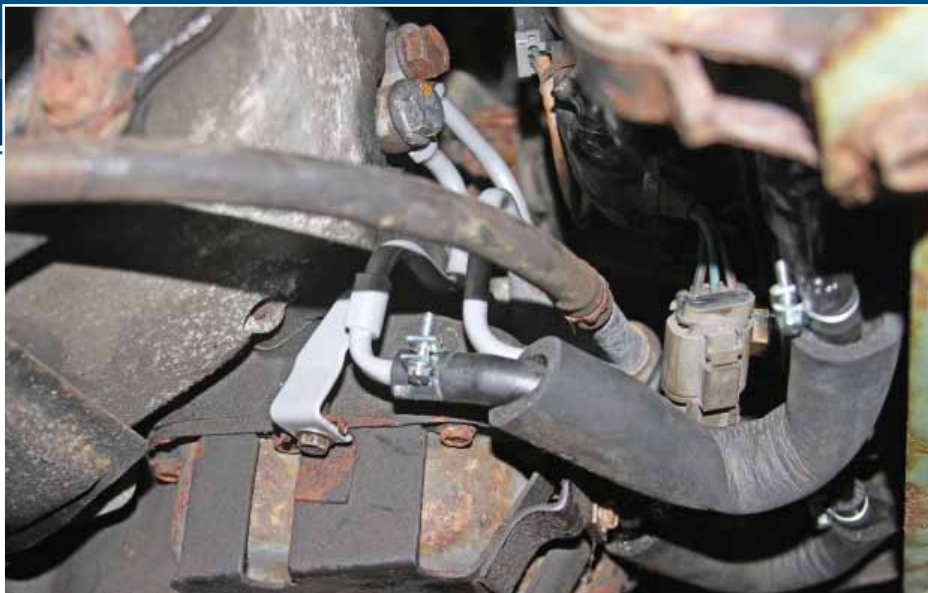
5 And here are the powder-coated pipes fitted to the transmission, taking the oil to rubber pipes that connect with the oil cooler in the bottom of the new radiator. Note the new pipe clips on the rubber hoses instead of the old wire ones.

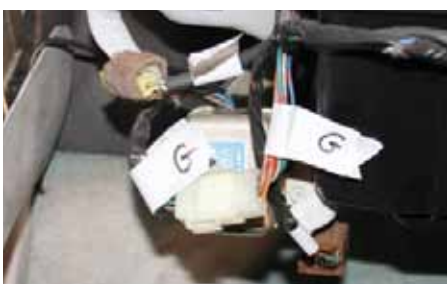
7 With so many electrical connections to break, Simon adopted a fool-proof method, labelling each side of every connection with masking tape and a unique letter. A goes with A, B goes with B and so on – simples!

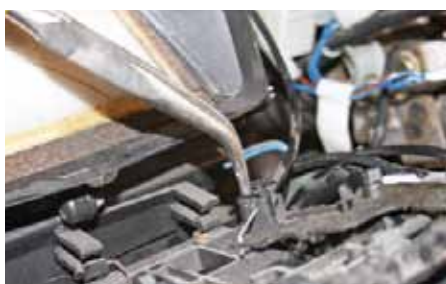
8 There is plenty of help and advice available, but no Haynes manual for instant referencing and so you do have to go carefully and be prepared to adopt plan B. Simon tried disconnecting the fresh air vent at the heater end first...

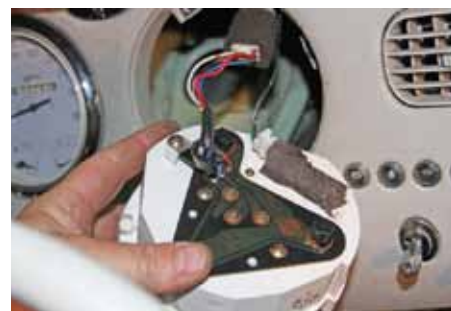
6 Finally there was no other reason to delay, and the interior had to be stripped. There is no need to repeat the whole dismantling process (such as removing the rev counter to access the speedo cable), much of which was detailed in previous issues.

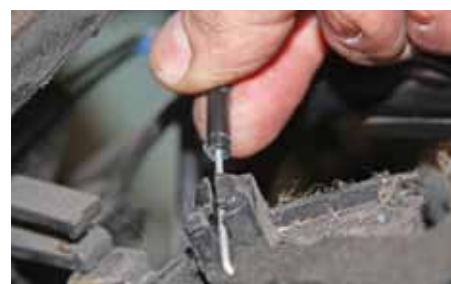
9 ...but couldn't get the cable angled far enough up to clear the stepped end. The wire is a solid rather than a stranded affair and he didn't want to introduce a permanent kink which would prevent it from operating smoothly...

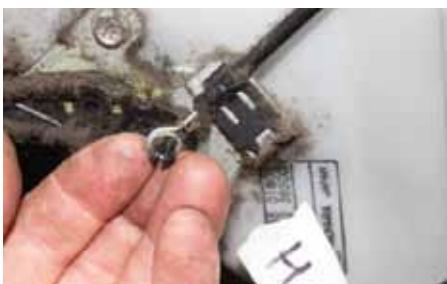
10 ...so in the end he opted to undo the cable at the other end and then pull it through from behind the heater. Taking plenty of pictures and making notes means he had a fighting chance of reassembling everything correctly.

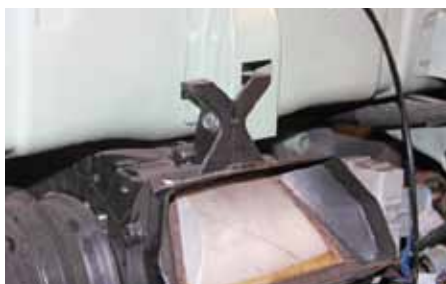
11 With the dash removed, it was then a matter of searching around the heater unit to locate and identify all the fixings. There was this plastic hook at the top that grips a bracket on the bulkhead and is secured with a single bolt.

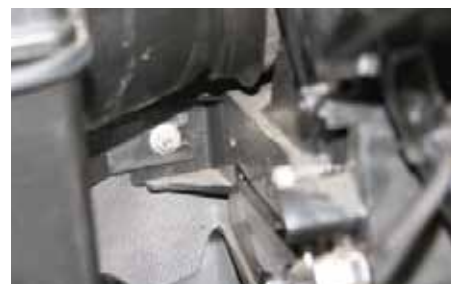
12 There was also a nut on either side securing the heater to a stud on the bulkhead. Unfortunately, on the passenger side the plastic lug on the heater unit went behind a corresponding lug on the aircon unit in the passenger footwell.

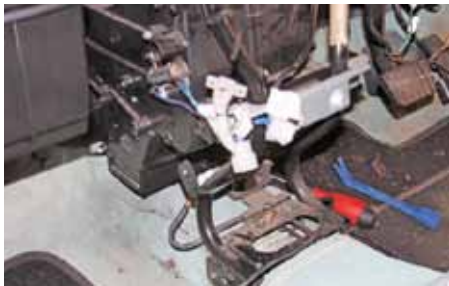
13 The slotted plastic lugs on the heater should have been able to slide sideways to clear those studs, but this support bracket on the transmission tunnel meant that there was not enough movement to get the heater out from behind the aircon unit.

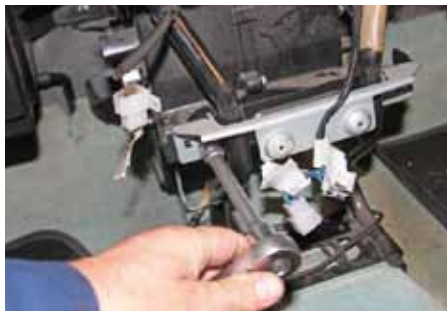
14 So the bracket had to come off too. It was then possible to manoeuvre the heater unit out, though with more flexing of the plastic than was comfortable. At least it meant the rigid lines to the air-con unit did not have to be disturbed.

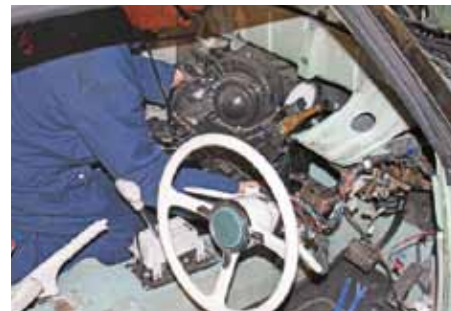
15 Finally the whole heater unit could be lifted carefully out of the car, taking care not to let any residual water still trapped inside pour out and onto the carpet. Oh for the easy access of an engine-bay heater on a Midget or MGB!

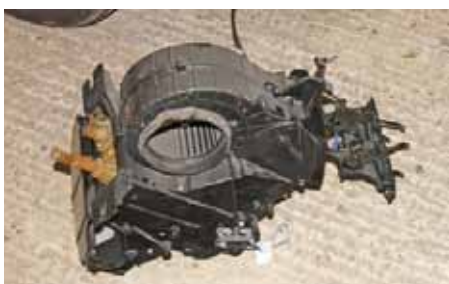
16 And this is the reason for it all. Note the two plastic pipes to the left that poke through the bulkhead and take hot coolant to the heater and then return it to the engine bay. Or rather, note the one stub and the broken remains of the other!

We left the Figaro last issue in disgrace, after one of the plastic take-off stubs on the heater had snapped off while I was changing the coolant hoses. I was changing the hoses because one had been nibbled by mice and I didn't want to take the chance of a hidden pipe being similarly afflicted and bursting at an inopportune moment. This was particularly galling because to change the heater matrix meant removing the entire dash, a job that I had only recently done in order to fit a leather-topped replacement.

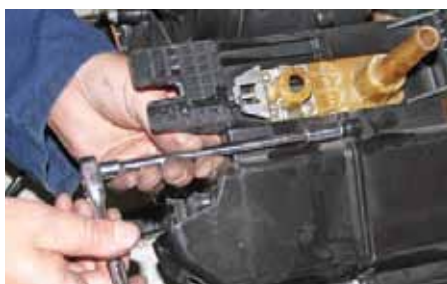
17 With the heater unit on the bench, work could start on separating the two halves of the plastic casing. Each bolt was checked as it came out – if any had been a different length to the others, its position would have been noted.

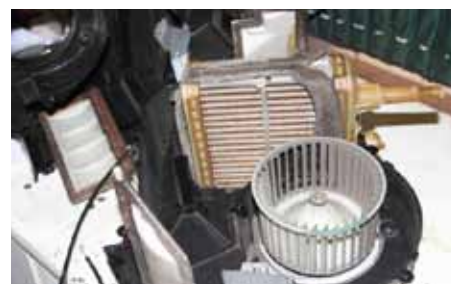
18 There was one fixing bolt hidden deep in a recess by the fan, but after that had been found it just needed the rod for the defunct valve to be removed and the unit could be opened to reveal the heater matrix that needed replacing.

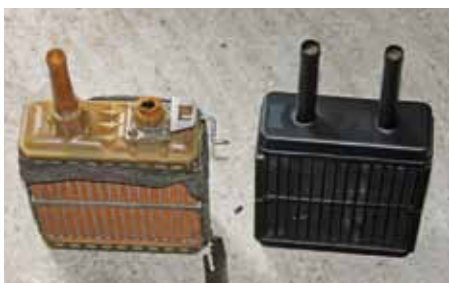
19 The new matrix has steel rather than plastic pipes, but is missing the valve. This is not a major concern because on the Figaro the face vents only blow cold air, so you can select the foot and screen vents when heat is required.

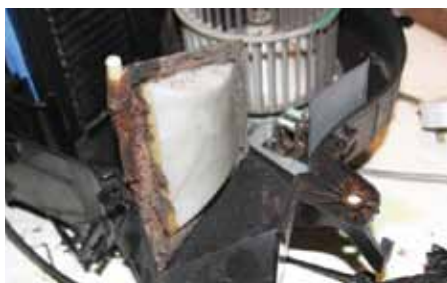
20 The old foam for the sealing flaps inside the heater was badly deteriorated and crumbling. This could have made it difficult to achieve a seal and direct the flow of warm or cool air efficiently to where it is needed.

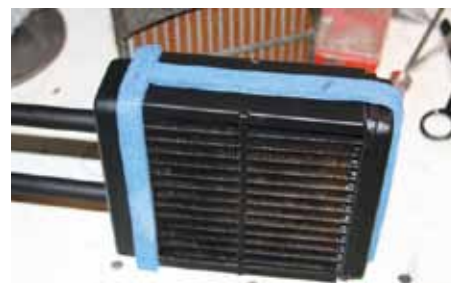
21 So Simon used new self-adhesive foam strips to wrap the new heater matrix, and also to replace the crumbling foam on the various directional flaps as well as the fan. This was slightly thicker than ideal, but did the job OK.

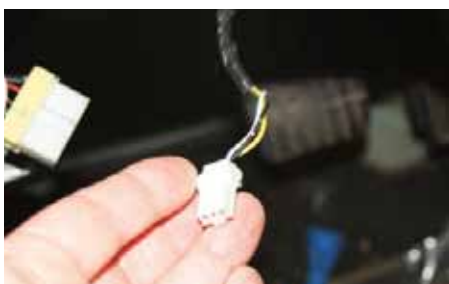
22 When reassembling everything, this unmarked connection was a concern, but we sent a picture of it to Simon Smith of the Figaro Owner's Club, who explained that it was not connected on Figaros, but was for an over-speed warning buzzer.

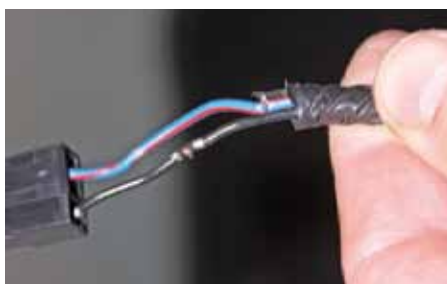
23 We also found a couple of wires whose insulation had been damaged, presumably by careless fitment of some plastic trim in the past. Simon wrapped them in insulating tape before putting everything back together.
